Service Information

Category S	Repair Guidance	Ref. No. R042/13A	Page 1 of 7
Coverage <input type="checkbox"/> Distributor only <input checked="" type="checkbox"/> Please inform your dealers		Date Issued June 21, 2013	
Please convey this information to your <input type="checkbox"/> Director <input checked="" type="checkbox"/> General Manager <input checked="" type="checkbox"/> Warranty Dept. <input checked="" type="checkbox"/> Parts Dept. <input checked="" type="checkbox"/> Training Dept. <input checked="" type="checkbox"/> Field Rep.		Date Revised August 6, 2013	
Applicable Model CX-5 (KE)	Applicable Countries or Specifications Europe

Subject: Outer mirror vibration when driving on highway

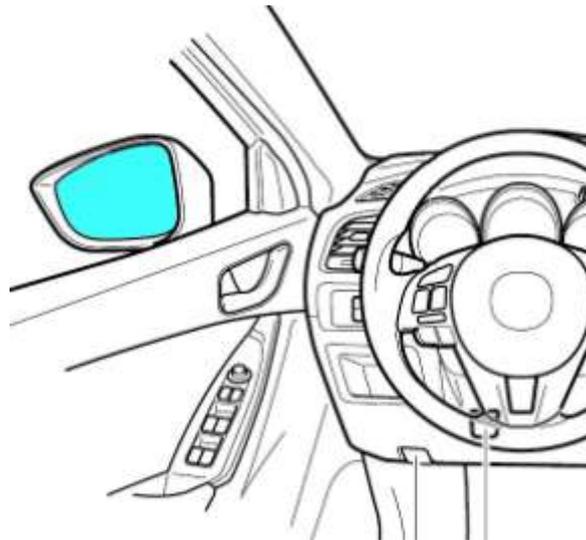
Some vehicles may exhibit a vibration on outer mirror when the vehicle is driven at high speed.

Due to a lack of rigidity of the outer mirror base, the mirror vibrates caused by vehicle vibration or wind pressure.

Depending on VIN, perform all applicable repair(s) according to the following chart.
