Subject: CARGO COMPARTMENT LIGHT BULB REPLACEMENT CAUTION	Bulletin No: 09-023/12
	Last Issued: 07/03/2012

2013 CX-5

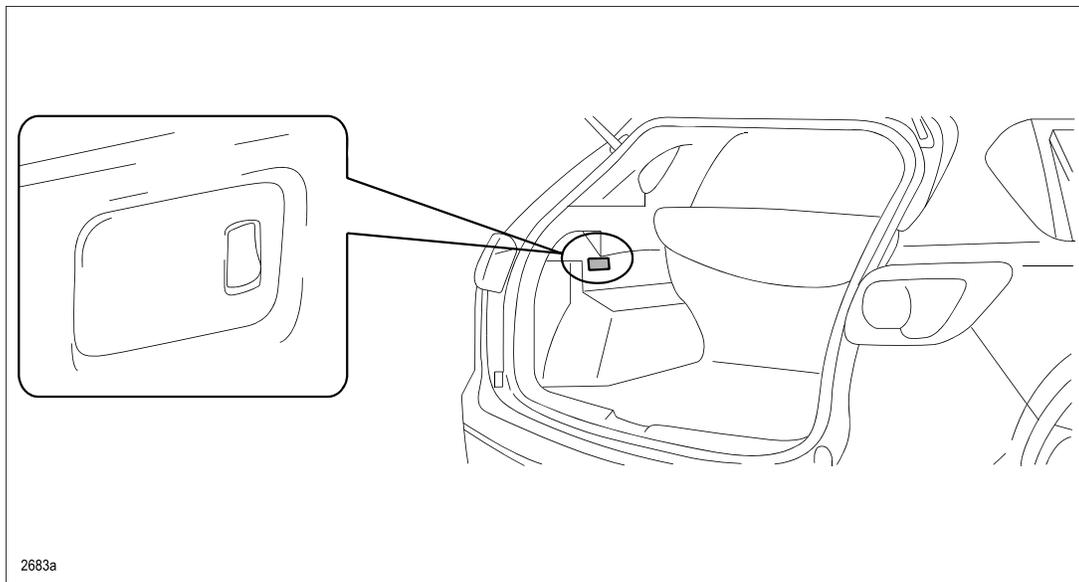
When replacing the light bulb in the cargo compartment, the battery power must first be interrupted to avoid damaging the rear body control module (RBCM).

- TO AVOID DAMAGING THE RBCM DURING CARGO COMPARTMENT LIGHT BULB REPLACEMENT, ALWAYS DISCONNECT THE NEGATIVE BATTERY CABLE OR THE CARGO LIGHT CONNECTOR.
- IF THE RBCM IS DAMAGED, IT WILL REQUIRE REPLACEMENT.

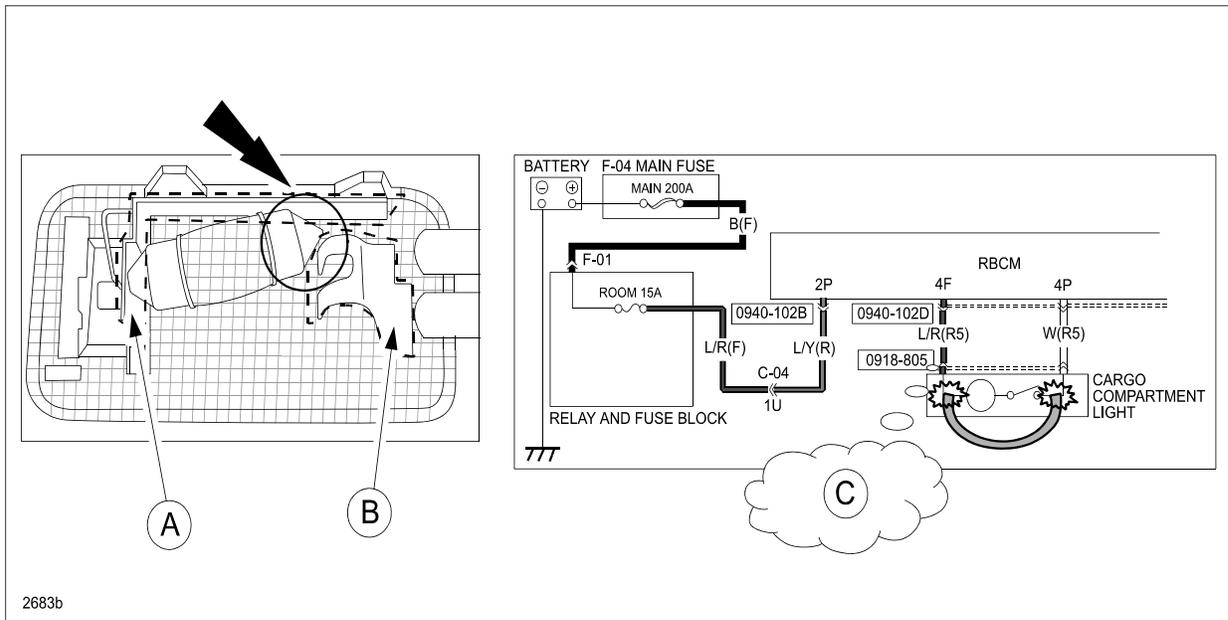
2683b

- TO AVOID DAMAGING THE RBCM DURING CARGO COMPARTMENT LIGHT BULB REPLACEMENT, ALWAYS DISCONNECT THE NEGATIVE BATTERY CABLE OR THE CARGO LIGHT CONNECTOR.
- If the bulb is removed (by hand or with a screwdriver) and battery power is still supplied to the cargo compartment light, the metal end of the bulb could cause a short circuit (C) between the negative (A) and positive (B) electrodes (as shown below). If this occurs, the RBCM will be damaged and will require replacement.

3. Replace the light bulb with a new one.
4. Re-connect the negative battery cable or the cargo light connector.
5. Verify repair.
