Service Information

| Category R | Repair Guidance | Ref. No. R025/13C | Page 1 of 2 |
| Applicable Model 2013 -2014 CX-5 (KE) and 2014 Mazda6(GJ) | | Applicable Countries or Specifications Worldwide | |

Subject: Knocking/Squeaking Noise from Front Strut Bearing

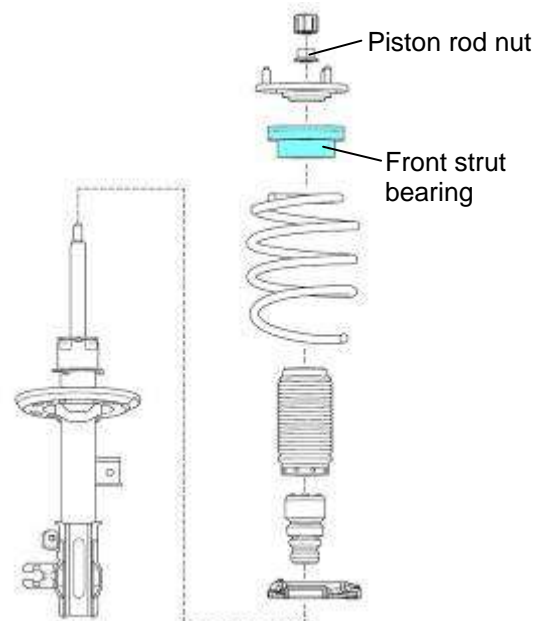
[Front shock absorber and coil spring]

Some vehicles may exhibit a knocking/squeaking noise from the front strut bearing due to the front strut bearing damage when driving on a rough road and/or turning the steering wheel at vehicle standstill.

The noise may occur due to the upper housing of the front strut bearing being damaged when applying excessive force to the bearing during customer’s usage.

Material and forming method of the front strut bearing have been changed.

Replace the damaged strut bearing with modified one according to the Workshop Manual.
