Subject: CONDENSATION / FOG IN FRONT AND REAR COMBINATION LIGHTS	Bulletin No: 09-016/09
	Last Issued: 11/19/2009

2003-2010 Mazda6
2004-2010 Mazda3
2006-2010 Mazda5
2006-2010 Mazda MX-5
2007-2010 Mazda CX-7
2007-2010 Mazda CX-9
2004-2010 Mazda RX-8

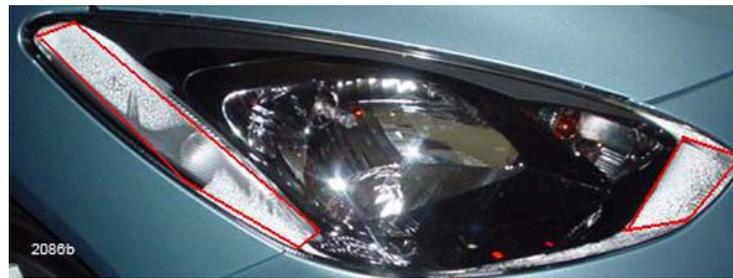
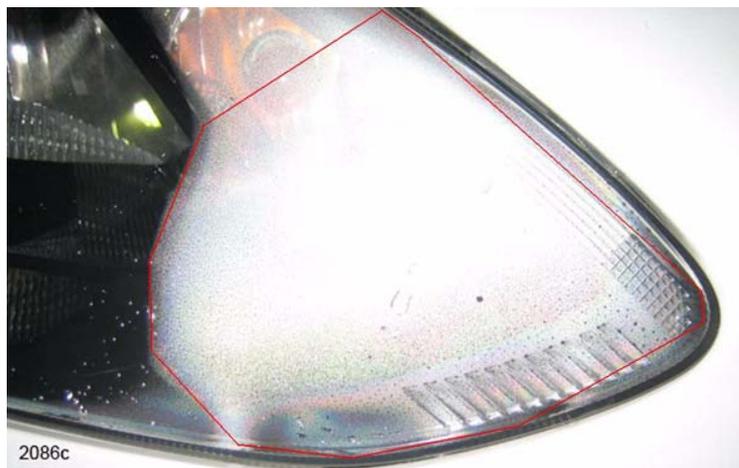
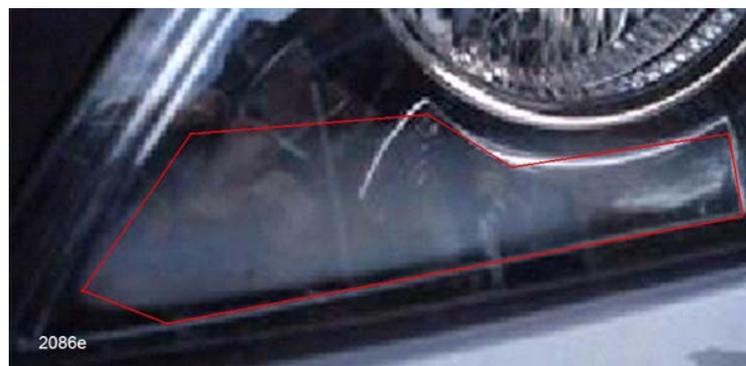
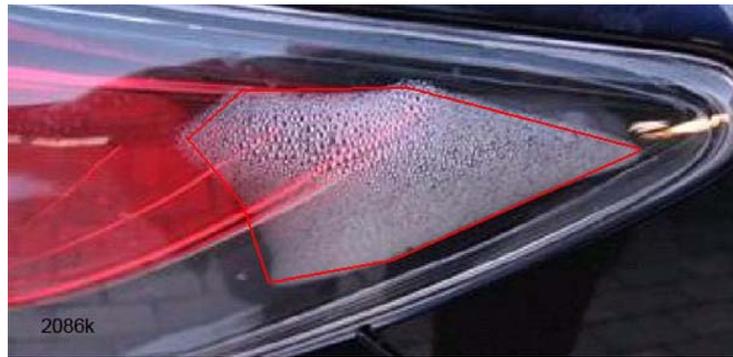
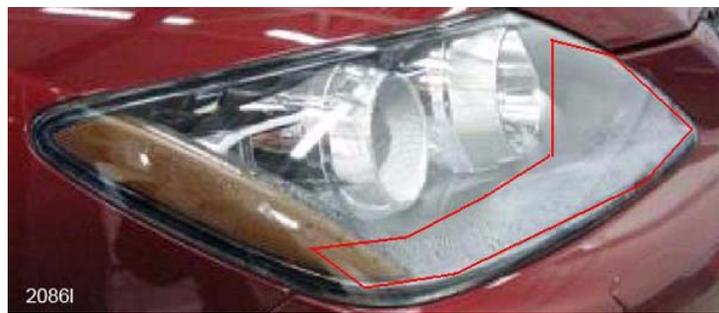
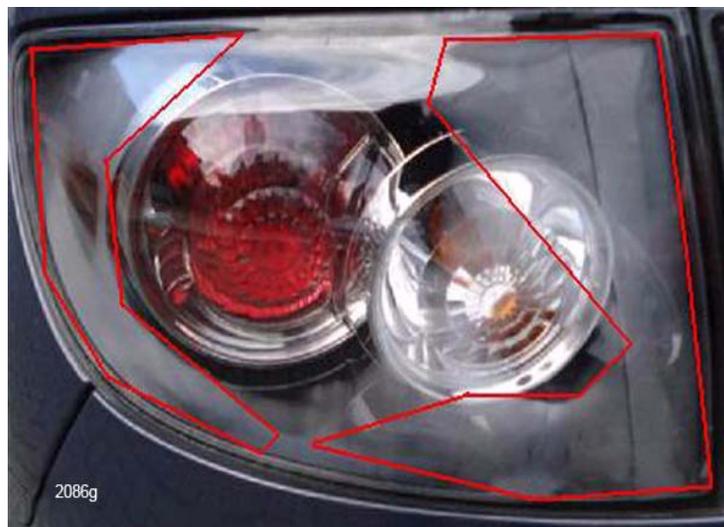
Condensation/fogging along the edges and in the corners is considered normal.

Explain to the customer that this is a natural phenomenon and not a quality defect. **DO NOT** attempt repairs as this is considered normal, **and is NOT covered under Warranty. Replacing the light unit will not correct this symptom.**

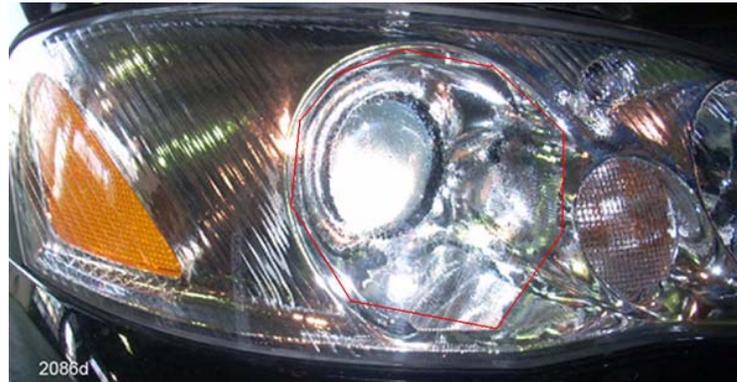
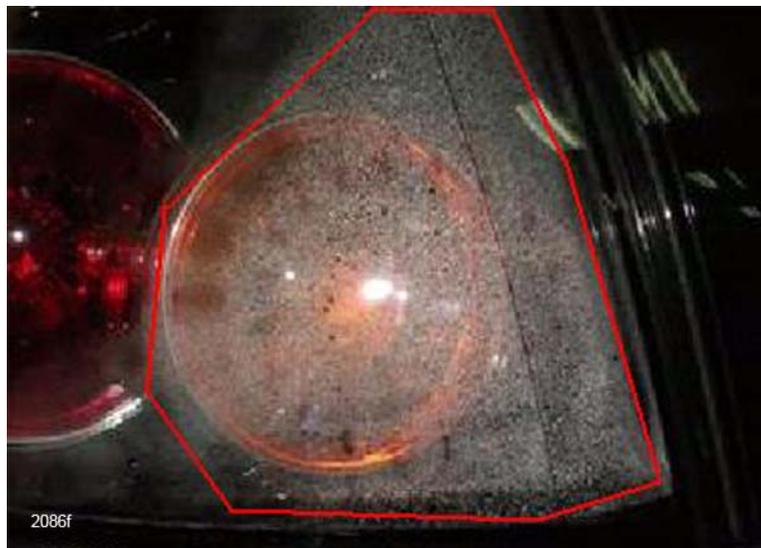
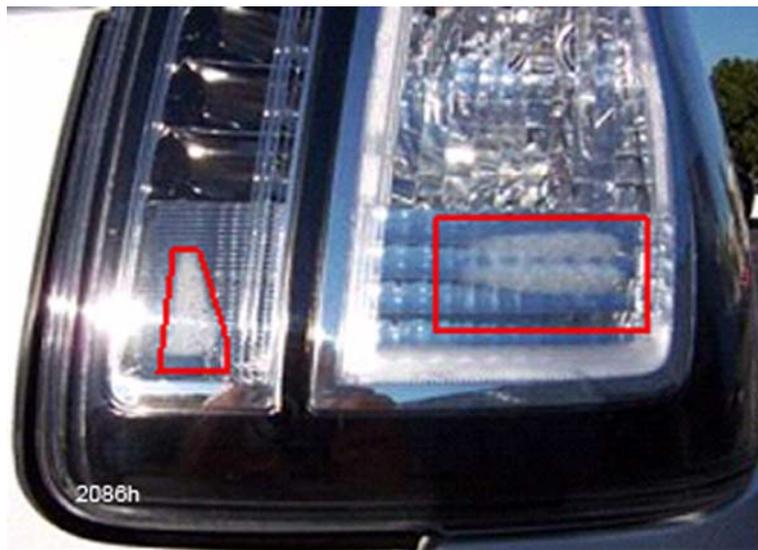
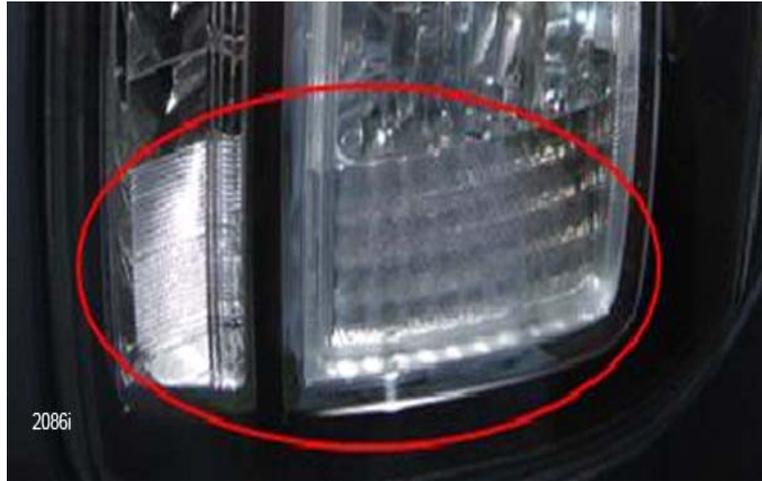
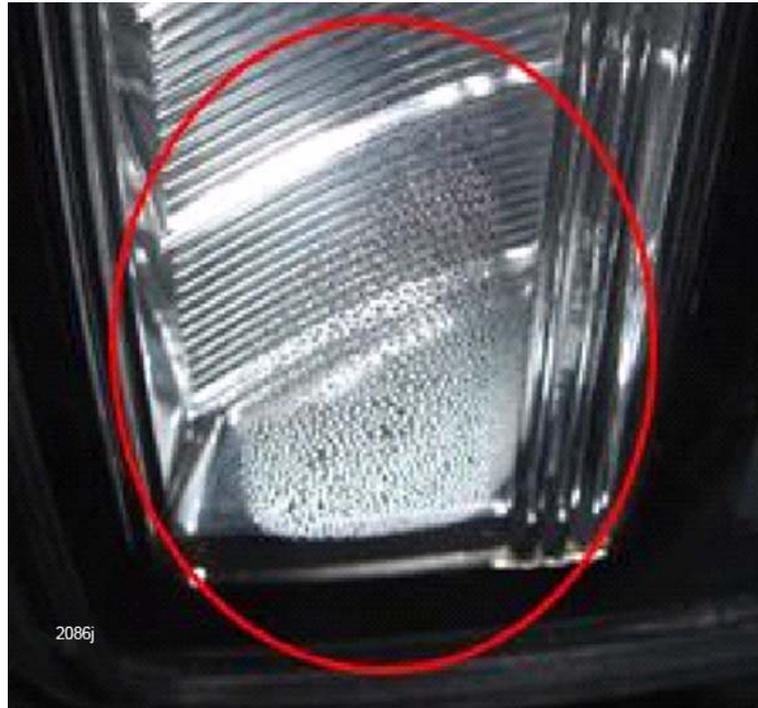
Some condensation/fogging on the lens is considered normal.

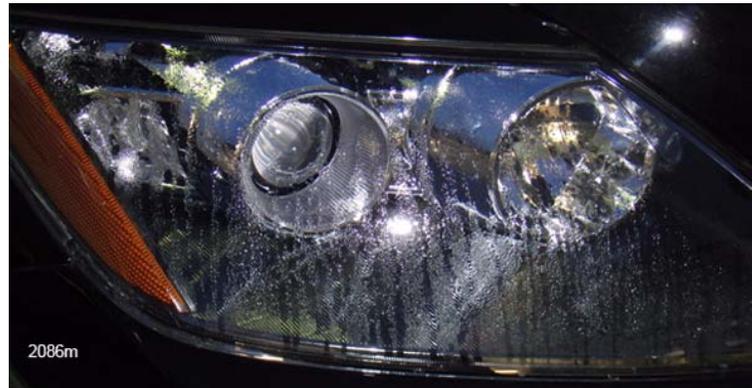
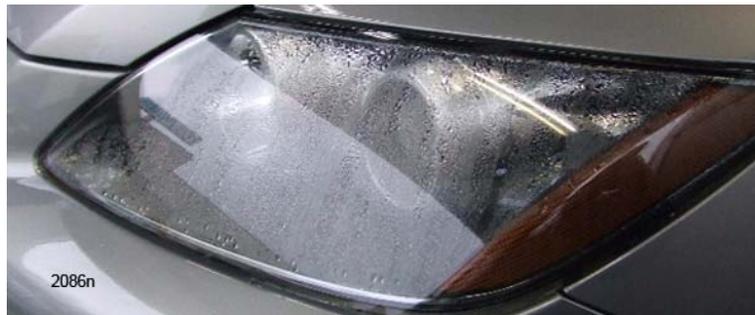
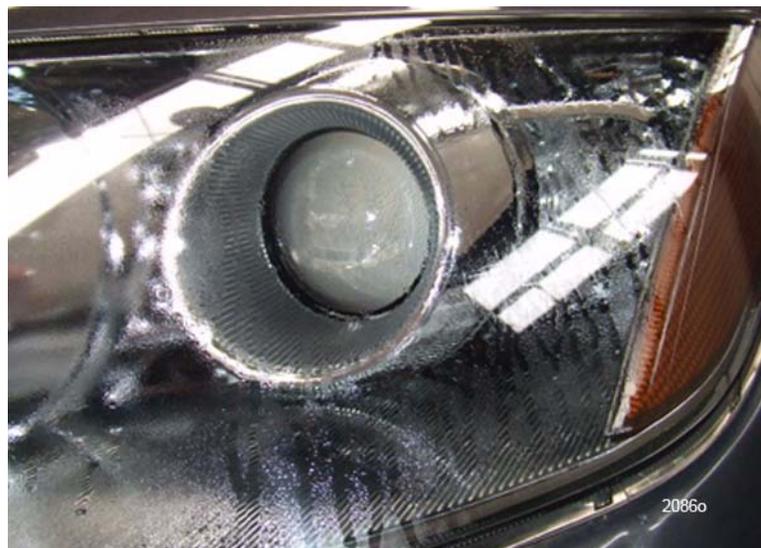
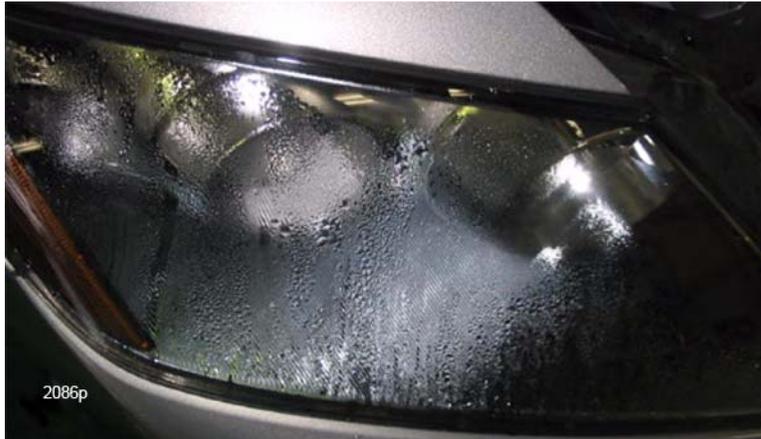
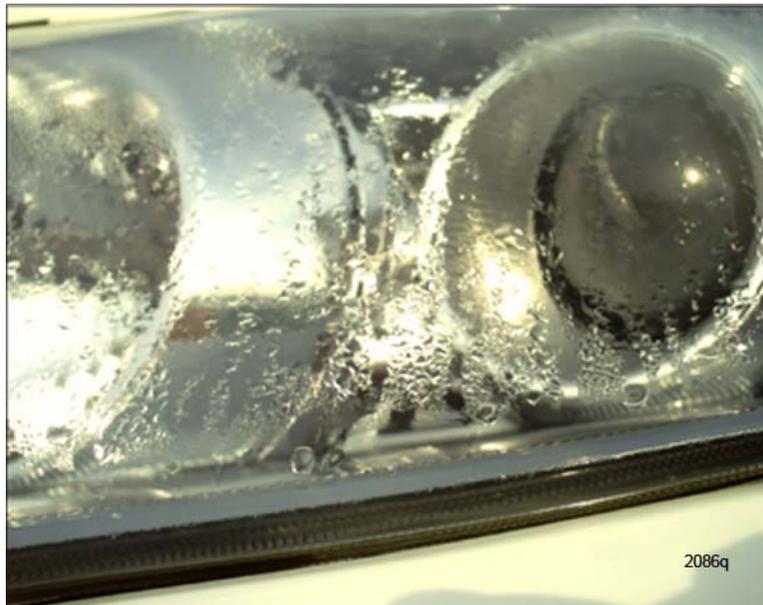
Water entry is where rain water comes into the inner light and stays as waterdrops on the inside of the lens. The possible causes of "water entry" because of a part issue are:

- Poor sealing joint between the lens and housing.
- Missing or poor sealing of gasket. (NOTE: If the light unit was previously repaired and any seals are missing, this is not covered under Warranty. Contact your DSM in this situation before replacing the light.)
- Cracked lens and/or housing.
- Poor installation of respiration tube at ventilation hole.

Heavy/large amount of condensation on the lens is not normal.

- If the condensation/fog clears, it is normal, and the light unit should not be replaced.
- If the condensation/fog does not clear, it is abnormal (water entry is suspected), and the light unit should be replaced.
