Subject: HESITATION / IDLE VIBRATION DUE TO CRACKED ENGINE MOUNT	Bulletin No: 01-021/06
	Last Issued: 6/13/2006

2004-2005 RX-8 vehicles with VINs lower than JM1FE*****154999 (produced before May 6, 2005)

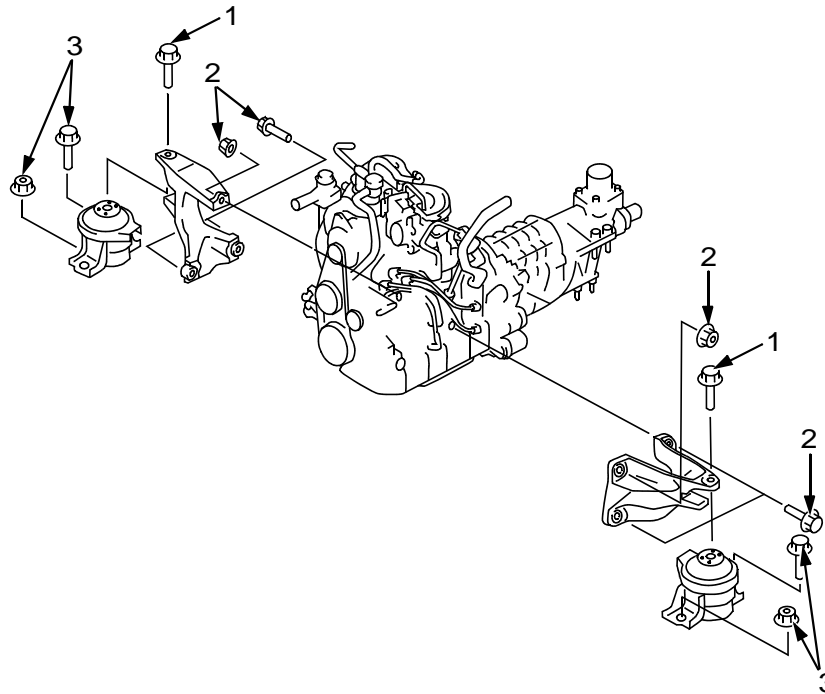
Depending on the driving condition or engine condition, the RH side engine mount rubber may deform. As a result, the RH side engine mount can crack. As a mass production change, the material of the engine mount rubber has been changed. To provide durability of the replaced RH engine mount, an engine bracket with insulator for RH side has been established together with modified engine mount for the LH side.

7. On RH side of engine, remove bolts/nuts in the following order:
 - a. Engine mount bracket-to-engine mount (1). - **Tightening Torque: 37-52 N.m (28-38 ft-lb)**
 - b. Engine mount bracket-to-engine (2). - **Tightening Torque: 43-61 N.m (32-45 ft-lb)**
 - c. Engine mount-to-front sub frame (3). - **Tightening Torque: 45-63 N.m (33-46 ft-lb)**

8. On LH side of engine, remove bolts/nuts in the following order:
 - a. Engine mount bracket-to-engine mount (1). - **Tightening Torque: 37-52 N.m (28-38 ft-lb)**
 - b. Engine mount-to-front sub frame (3). - **Tightening Torque: 45-63 N.m (33-46 ft-lb)**
9. To install, reverse removal procedure.
10. Verify repair.
