Subject: NO SOUND FROM AUDIO UNIT IN COLD CONDITIONS	Bulletin No: 09-053/10
	Last Issued: 12/16/2010

2011 Mazda2 vehicles with VINs between JM1DE1H**B0100037 - 117771 (produced between May 14, 2010 and Nov. 3, 2010)

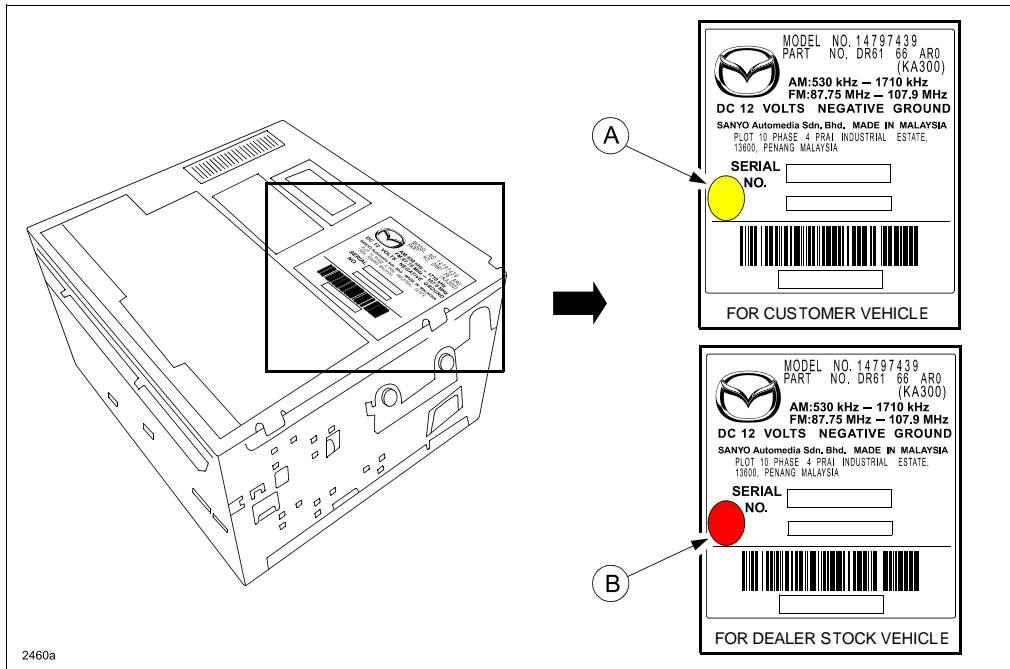
NOTE: The part number has not changed. To identify a new or old audio unit, see the marking on the parts label as shown below.

Modified audio unit with yellow marking (A) on label is for customer vehicles only.

Modified audio unit with red marking (B) on label is for dealer stock vehicles only.

CAUTION: DO NOT INSTALL AN AUDIO UNIT WITH A YELLOW MARKING (A) ON LABEL ON A DEALER STOCK VEHICLE.

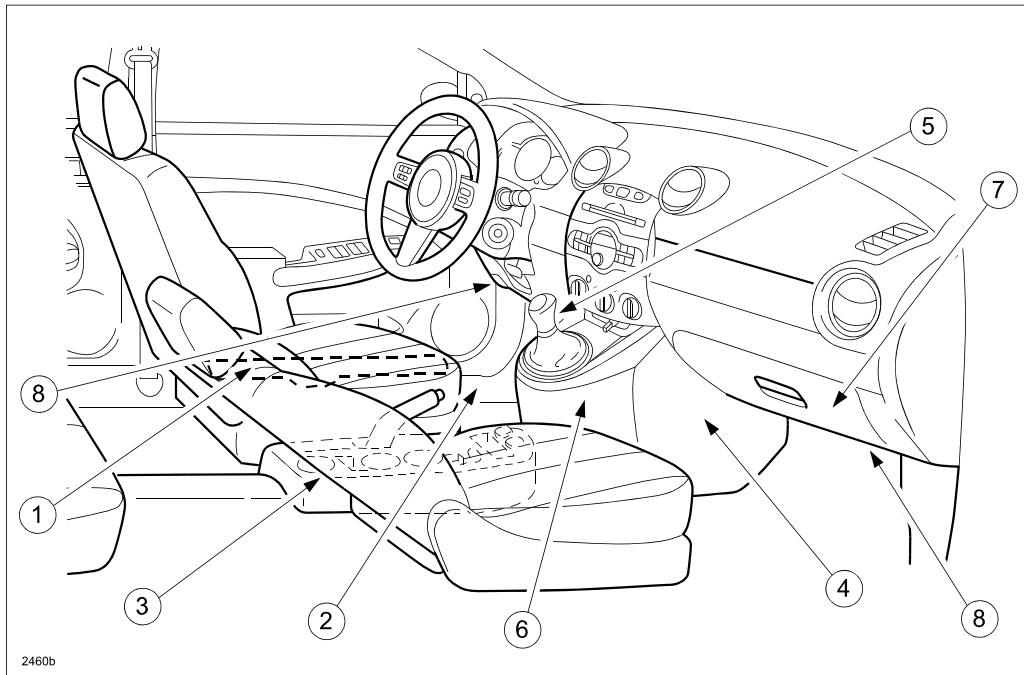
1	Front scuff plate (both sides)	5	Shift lever knob (MTX)
2	Front side trim (both sides)	6	Front console component
3	Rear console	7	Glove compartment
4	Side wall (both sides)	8	Lower panel (both sides)

1. Verify customer concern.
2. Record customer's pre-set radio stations.
3. Disconnect the negative battery cable.
4. Remove the following parts in the order shown below.

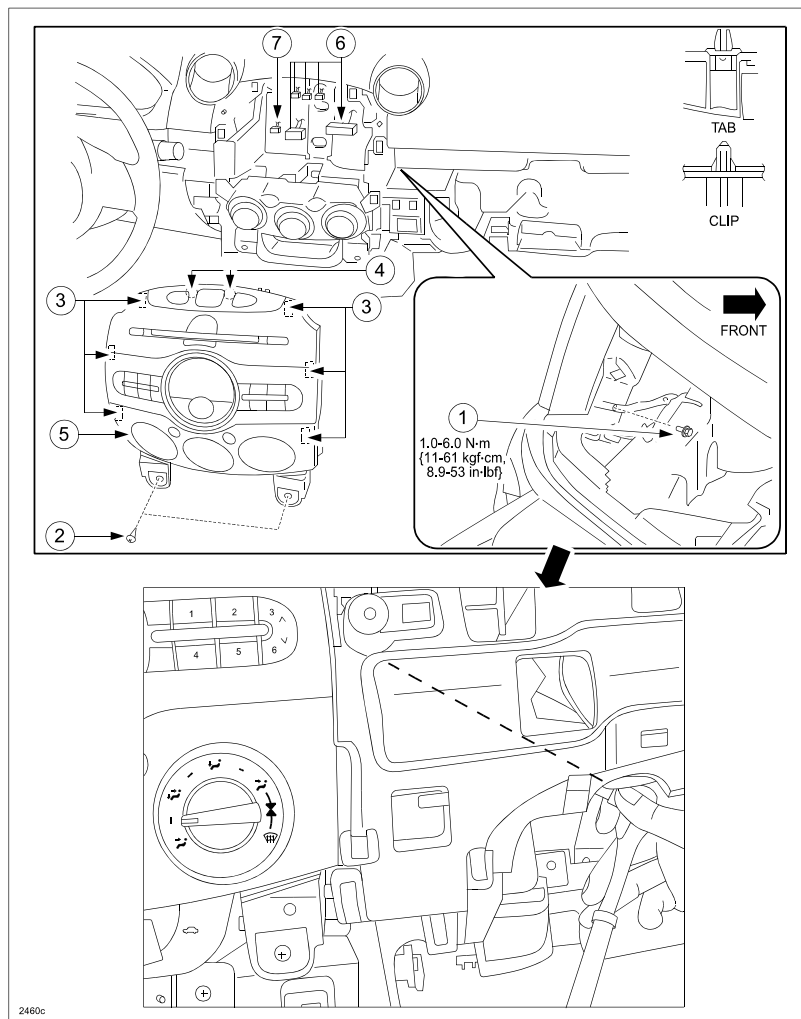
1	Bolt	5	Center Panel Unit
2	Screws	6	Connectors
3	Clips	7	Antenna Feed
4	Tabs

CAUTION: If Bolt (1) is not removed, dash panel damage may occur.

5. Remove the center panel unit in the order shown below.

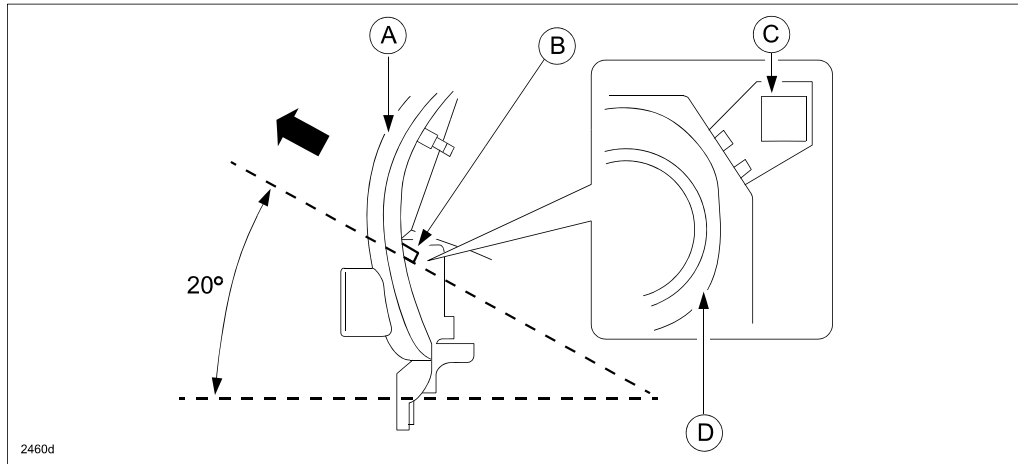
CAUTION: When the center panel unit (A) is removed, the clips (B) could interfere with the climate control unit (D) bracket (C) and cause damage. Pull the center panel unit in the direction of the arrow shown below (upward at approx. 20° angle).

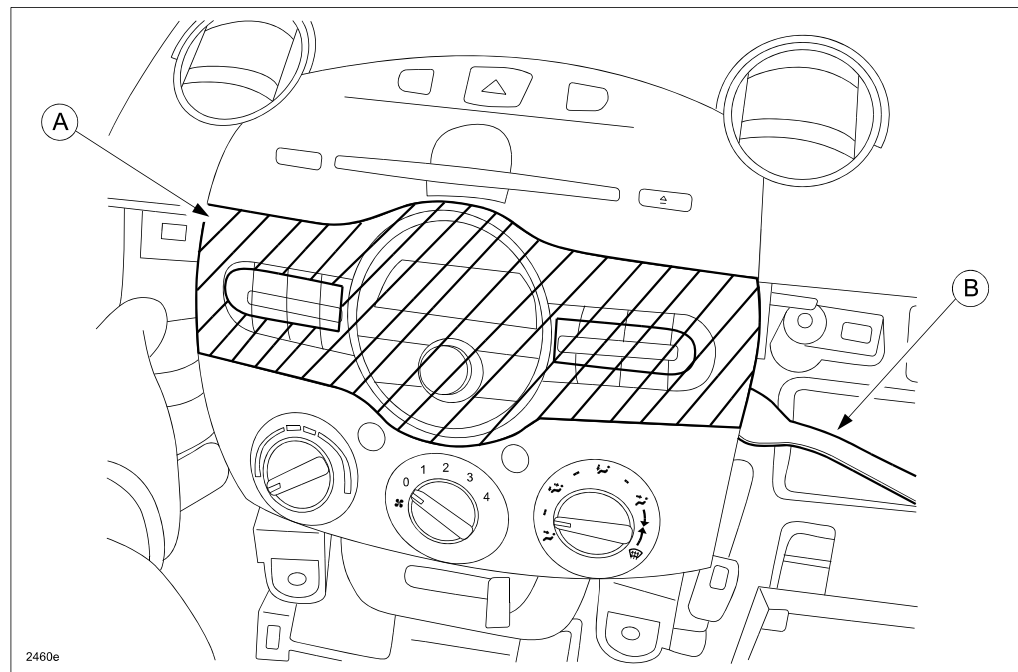
NOTE: If it is difficult to remove the center panel unit by hand, use a tape-wrapped fiber stick (B) or equivalent as shown below.

CAUTION: Do not damage/scratch the cross-hatched area (A).

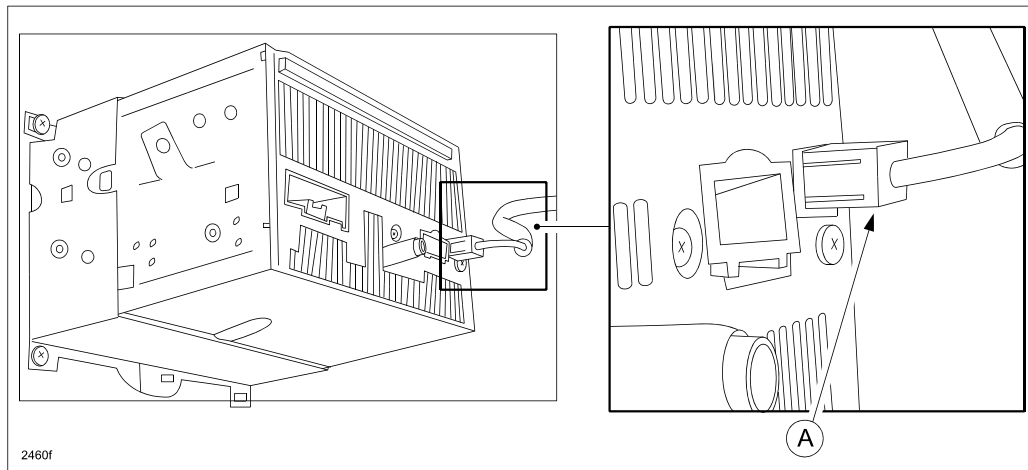
CAUTION: When disconnecting the antenna feeder coupler (A), make sure to pull the coupler, not the wire. Pulling the wire could cause it to separate from the coupler.

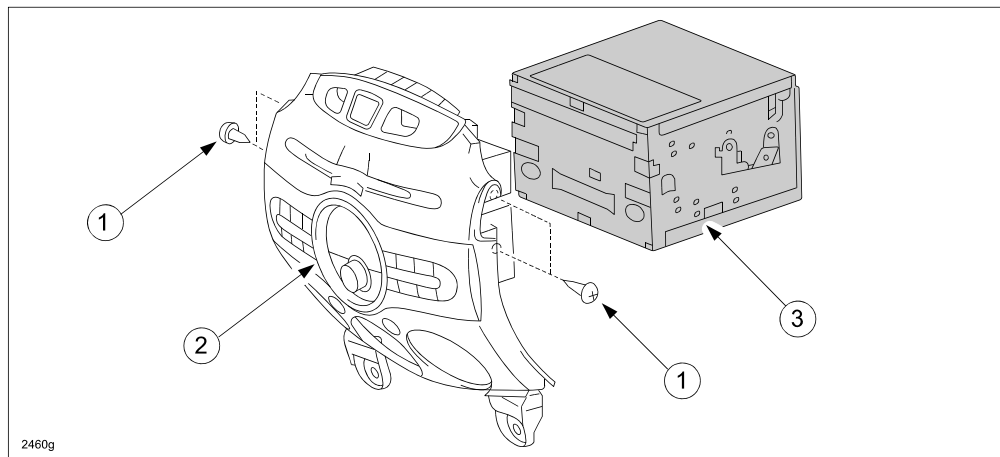
1	Screws	3	Audio Unit
2	Center Panel

6. Remove the audio unit from center panel in the order indicated below.
