Service Information

Category S	Repair Guidance		Ref. No. R017/12	Page 1 of 2
Coverage □ Distributor only ■ Please inform your dealers			Date Issued February 23, 2012	
Please convey this information to your □ Director □ General Manager Warranty Dept. □ Parts Dept. □ Training Dept. □ Field Rep.		Date Revised		
Applicable Model		Applicable Countries or Specifications		
CX-5 (KE)		North America, Europe

Subject: Rattle noise from instrumental panel when driving on rough roads or over bumps

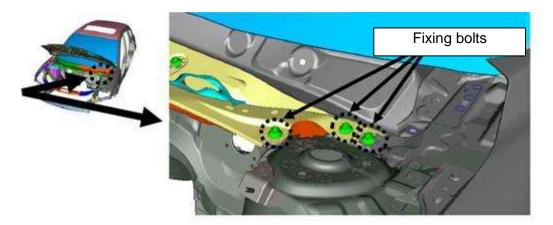
Low torque of cowl panel fixing bolts.
