Service Information

Category S	Repair Guidance		Ref. No. R020/12	Page 1 of 3
Coverage ☐ Distributor only ■ Please inform your dealers			Date Issued March 1, 2012	
Please convey this information to your ☐ Director ☐ General ☐ Warranty Dept. ☐ Parts Dept. ☐ Training Dept. ☐ Field I		l Manager Rep.	Date Revised	
Applicable Model		Applicable Countries or Specifications		
CX-5 (KE)		Europe and North America

Subject: Large Clearance on top of A-pillar Trim

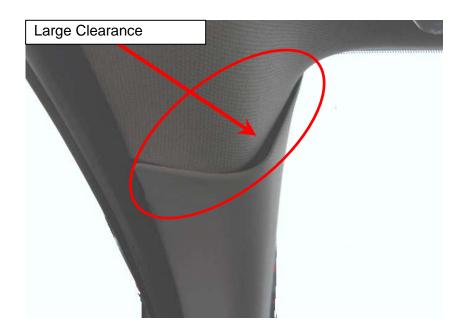
Some vehicles may exhibit large clearance on top of A-pillar which gives poor appearance as shown below.

A-pillar trim clip did not fit properly due to a piece of curtain air bag caught in the clip.

When you encounter a customer complaint on this concern, tighten the A-pillar trim as per the following procedure.

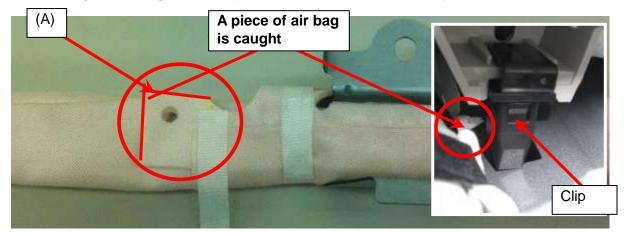
2. If a piece of curtain air bag (A) is caught in the clip, go to next step. (If air bag is not caught in the clip, this information does not apply.)
