Service Information

Category T	Repair Guidance		Ref. No. R024/12 <mark>A</mark>	Page 1 of 2
Coverage Distributor only Please inform your dealers			Date Issued March 16, 2012	
Please convey this information to your □ Director □ General Manager Warranty Dept. □ Parts Dept. □ Training Dept. □ Field Rep.			Date Revised December 21, 2012	
Applicable Model		Applicable Countries or Specifications		
CX-5 (KE) <mark>& Mazda6 (</mark>	(GJ) with SKYACTIV-G 2.0	Worldwide

Subject: MIL Illumination with DTC P2610

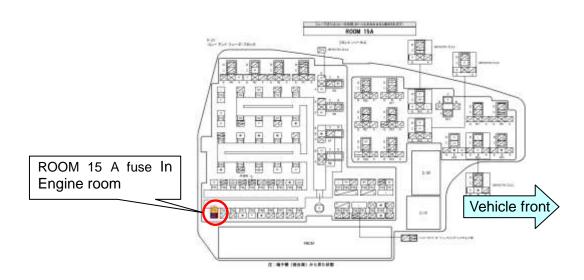
Some vehicles may experience MIL illumination with DTC P2610 stored in memory after engine start under the room fuse was removed.

P2610:00: Instrument cluster internal engine off timer performance problem

If the vehicle is started with below condition, some vehicle store the DTC P2610 and illuminate the MIL.

* Start the engine 3 times or more with short engine off time less than 15 seconds without room fuse.

When the MIL is illuminated (DTC P2610) without room fuse at PDI, delete the DTC code following procedure below.

- 1) Install the room fuse with IG switch off position.
- 2) Start the engine and run it 10 seconds or more, and then stop the engine.
- 3) Start the engine again and confirm the MIL is not illuminated, and then stop the engine.
- 4) Clear the DTC P2610.
- 5) If the DTC P2610 is still stored, perform troubleshooting according to Workshop Manual.
