<b>Subject:</b>  NEW MODEL SERVICE CAUTIONS	<b>Bulletin No:</b> 00-002/12
	<b>Last Issued:</b> 04/03/2012

2013 CX-5

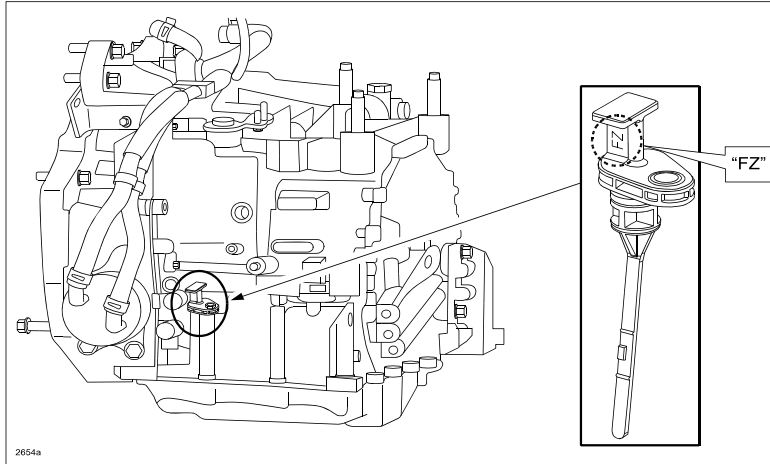
Only use "Automatic Transmission Fluid (ATF) FZ" for SKYACTIV-DRIVE. "ATF-FZ" is a low viscosity formula with less friction for better fuel economy. If an ATF other than "ATF-FZ" is used in the SKYACTIV-DRIVE ATX, the performance and reliability cannot be guaranteed. Any resulting damage will not be covered by warranty.

**NOTE:** ATF-FZ is colored blue, for easy identification. For ATX that requires ATF-FZ, "FZ" is marked on the dipstick as shown below.

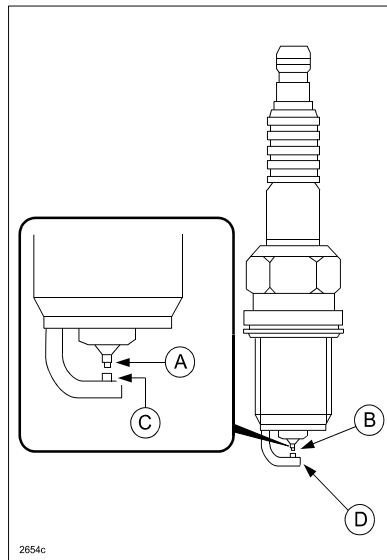
In order to achieve optimum ignition performance, SKYACTIV-G spark plugs use iridium (A) on an extremely thin center electrode (B) and platinum (C) on the ground electrode (D). Using general nickel or iridium plugs for the SKYACTIV-G engine could result in engine knocking, MIL illumination and/or poor driveability.

Only use the designated spark plugs for the SKYACTIV-G engine.

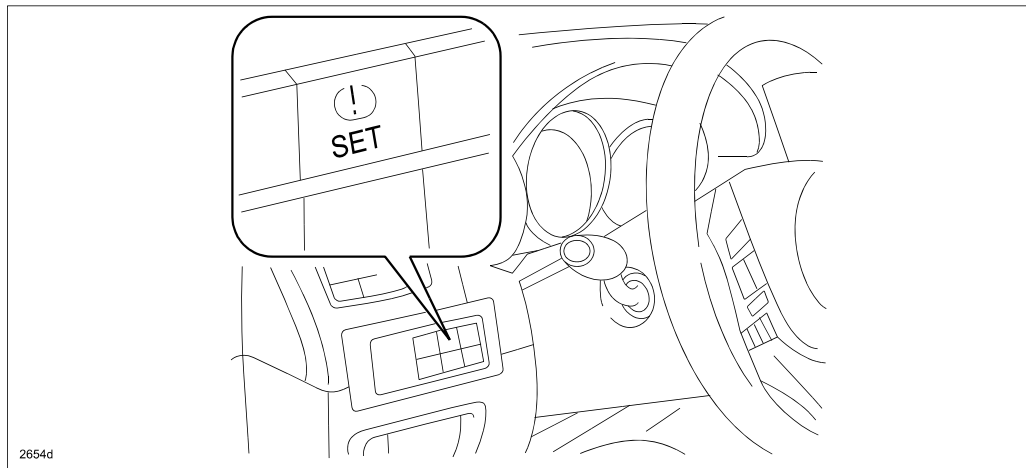
The tire pressure monitoring system monitors the tire pressure based on the signal from the ABS wheel-speed sensors on each wheel. With this system, initialization is required in the following cases:

- The tire pressure is adjusted (up or down) in one or more tires.
- A tire rotation is performed.
- Any tire or wheel is replaced.
- The vehicle's battery is disconnected, replaced or completely dead.
- **The DSC HU/CM has been replaced.**
- **The DSC HU/CM connector has been disconnected.**
- The TPMS warning light is illuminated.

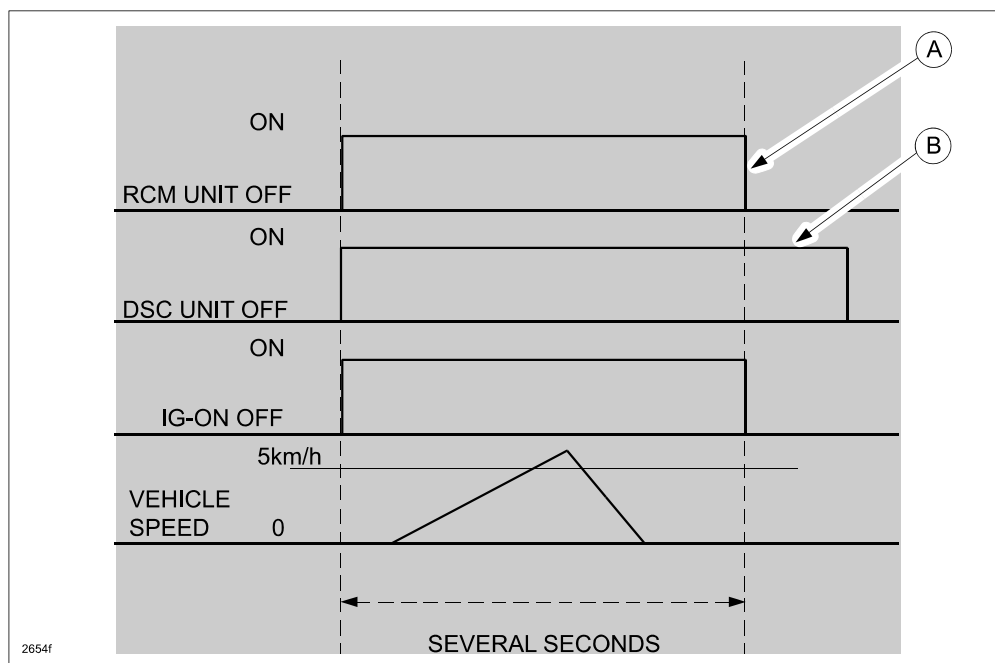
DTC U0151:00 ([DSC]: Communication error with SAS control module is detected in CAN communication) may be stored in memory as a past malfunction.

The DTC may be caused when the engine is started and the vehicle is driven immediately at 2 ~ 3 mph, then the ignition is turned off within several seconds.

While the DSC unit tries to communicate for a few seconds after the ignition is turned off, the RCM unit (SAS control unit) immediately stops communication when the ignition is turned off (A) at the self diagnosis stage. The DSC unit determines it as a communication error and sets the DTC as a result.

When the ignition is kept on longer than the self diagnosis stage (B), the RCM unit becomes able to communicate for a few seconds after the ignition is turned off, so the DTC will not be stored.

If DTC U0151:00 is found, check the following:

- Verify DTC U0151:00 is stored as a past malfunction.
- Other DTCs may also be stored that are not related to the symptom in this service information. Therefore, to eliminate DTC U0151:00, it is always recommended to check the service information independent from other DTCs.
- Check snapshot data item "IG-ON\_TIMER" (time since ignition switch ON). Verify the time is between "00:00" and "00:08" (mm:ss).

When all of the above factors are applicable, it is normal operation of the DSC and not a concern that requires a repair. Clear the DTC and check whether it occurs again under normal driving conditions. If the DTC recurs, refer to the online instructions on MS3 or the Workshop Manual for further troubleshooting information.
