Service Information

Category G	Repair Guidance	Ref. No. R092/12A	Page 1 of 2
Coverage <input type="checkbox"/> Distributor only <input checked="" type="checkbox"/> Please inform your dealers		Date Issued December 19, 2012	
Please convey this information to your <input type="checkbox"/> Director <input checked="" type="checkbox"/> General Manager <input checked="" type="checkbox"/> Warranty Dept. <input checked="" type="checkbox"/> Parts Dept. <input checked="" type="checkbox"/> Training Dept. <input checked="" type="checkbox"/> Field Rep.		Date Revised January 31, 2013	
Applicable Model Mazda6 (GJ) with i-ELOOP		Applicable Countries or Specifications Worldwide (except North America)

Subject: Charging System Warning Light Illumination with DTC P0A94:00/U3000:49

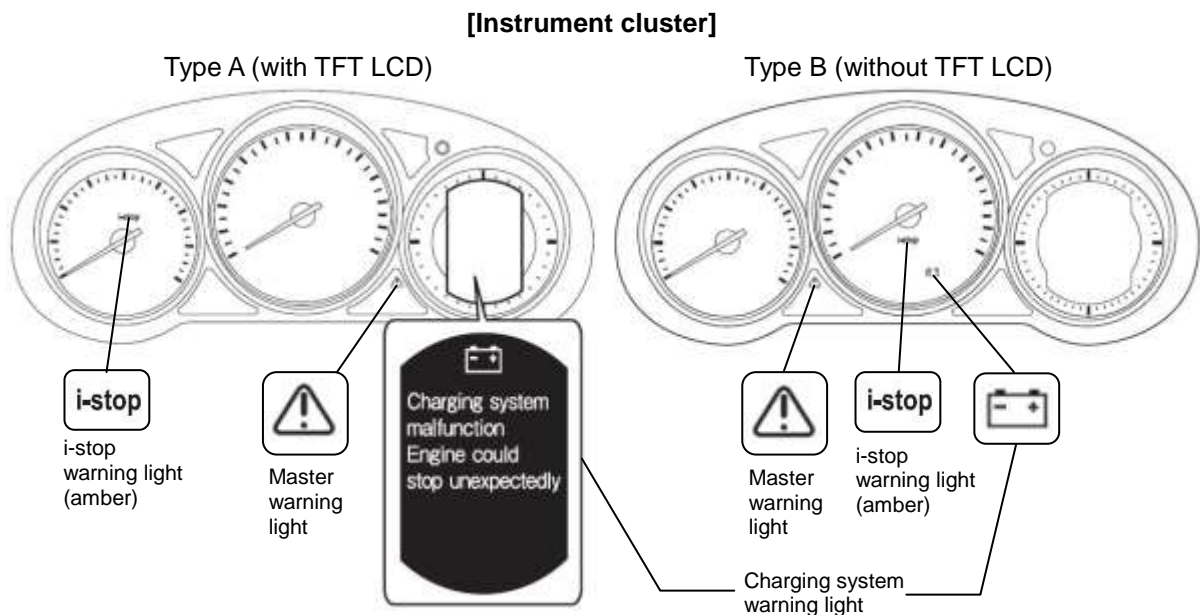
- 1) The charging system warning light suddenly illuminates.
- 2) The i-stop warning light (amber) and the master warning light suddenly flash.

When vehicle electrical load (current dissipation) exceeds 50A or more, the switching IC within the DC-DC converter is turned on to regulate the current. At this time, a surge voltage is generated and some IC with less withstand voltage due to variation could be damaged.

When you encounter a customer complaint on this concern, replace the DC-DC converter with modified one according to the Workshop Manual "DC-DC CONVERTER (i-ELOOP) REMOVAL/INSTALLATION [i-ELOOP]".
