Service Bulletin Mazda North American Operations

Subject: **Bulletin No:** 09-027/12

CHATTER NOISE FROM STEERING COLUMN COVER

2013 CX-5 vehicles with VINs lower than JM3KE*****130551 (produced before June 13, 2012)

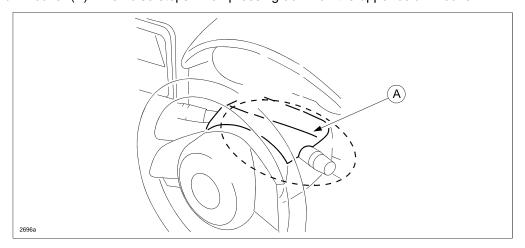
When driving on rough roads, some vehicles may exhibit a chattering noise which is heard around the upper steering column cover (A). The noise stops when pressing down on the upper column cover.

Due to variations in assembly, the start/stop unit harness bracket may interfere with the upper column cover causing the chattering noise.
