Service Information

Category S	Repair Guidance	Ref. No. R018/13	Page 1 of 4
Coverage <input type="checkbox"/> Distributor only <input checked="" type="checkbox"/> Please inform your dealers		Date Issued March 5, 2013	
Please convey this information to your <input type="checkbox"/> Director <input checked="" type="checkbox"/> General Manager <input checked="" type="checkbox"/> Warranty Dept. <input checked="" type="checkbox"/> Parts Dept. <input checked="" type="checkbox"/> Training Dept. <input checked="" type="checkbox"/> Field Rep.		Date Revised	
Applicable Model Mazda6 (GJ) Sedan	Applicable Countries or Specifications Worldwide

Subject: Clicking Noise when opening Trunk Lid

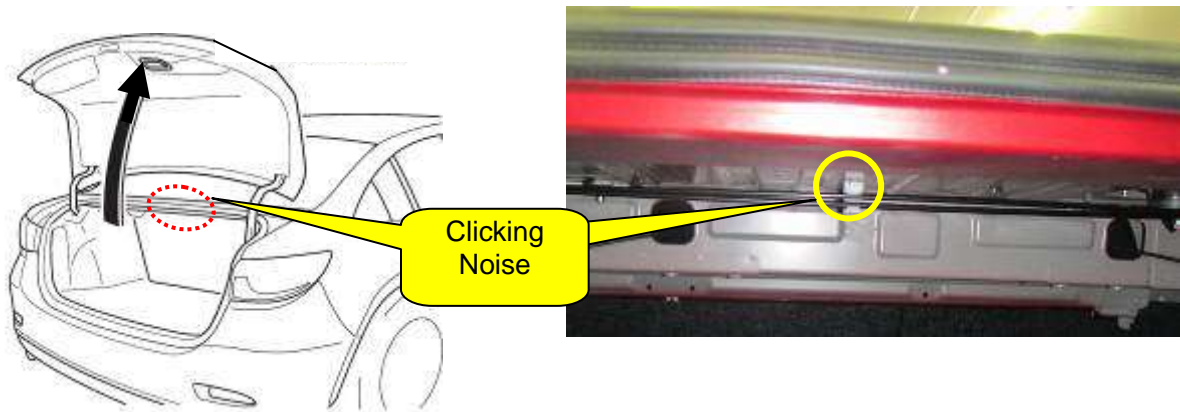
Some vehicles may exhibit a clicking noise at the moment the trunk lid is opened to the fully open position or just before the fully open position.

The balance springs are twisted when trunk lid is opened. This twisting motion causes the clip fixing the balance springs to move and scrape against the rear package tray panel, resulting in noise.
