Subject: DOOR GLASS RUN CHANNEL OUT OF POSITION	Bulletin No: 09-020/12
	Last Issued: 08/10/2012

2013 CX-5 with VINs lower than JM3 KE*****122801 (produced before May 8, 2012)

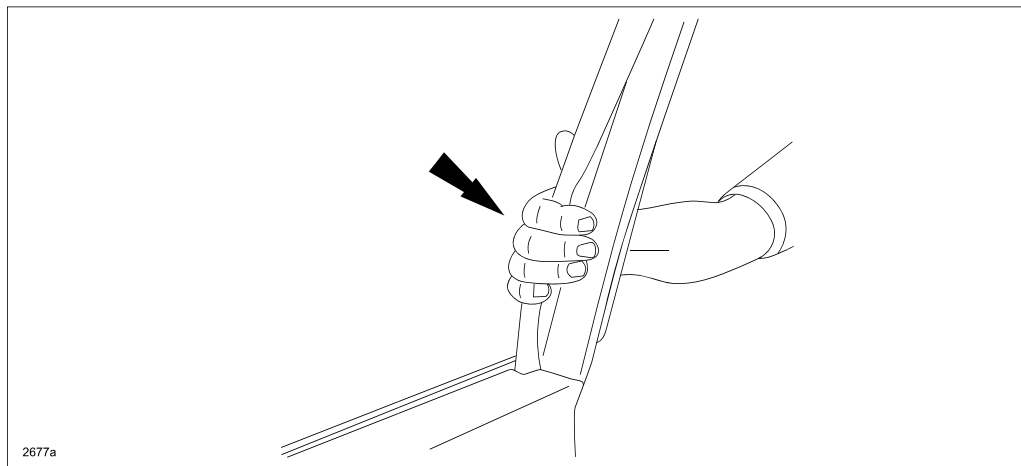
Some vehicles may experience a front door glass run channel that has slipped out of position causing a poor appearance concern.

While the window is open, a person might open or close the door by holding the door sash (as shown below) and cause the door glass run channel to be pulled out of position.

To prevent the glass run channel from slipping from out of position, a coating has been applied to the outer surface of the glass run channel to decrease frictional resistance.
