# Service Bulletin Mazda North American Operations

Subject: **Bulletin No:** 09-002/13 **DRIVER-SIDE POWER DOOR MIRROR VIBRATION** Last Issued: 02/26/2013

2013 CX-5 vehicles with VINs lower than JM3KE\*\*\*\*\*168885 (produced before November 16, 2012)

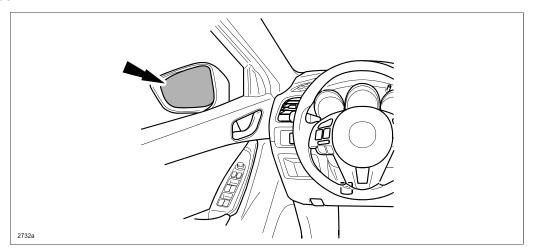
Some vehicles may exhibit a vibration from the driver-side power door mirror glass when the vehicle is driven at high speeds.

This concern may be due to a lack of rigidity of the mirror base so the mirror vibrates when it receives vehicle vibration or wind pressure.

Customers having this concern should have their vehicle repaired using the following repair procedure.
