Subject: FRONT SEAT CUSHION COMING OFF SEAT FRAME - (CLOTH SEAT ONLY)	Bulletin No: 09-035/12
	Last Issued: 08/28/2012

2013 CX-5 vehicles equipped with cloth seats with VINs lower than JM3KE*****129783 (produced on or before June 8, 2012)

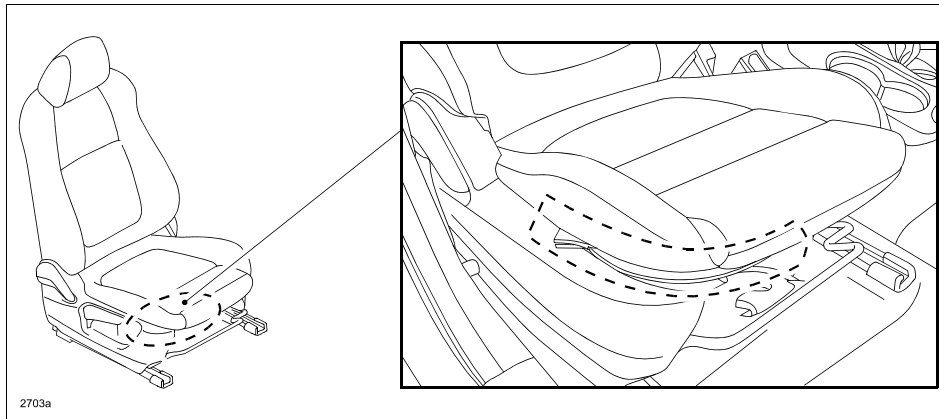
Some vehicles may exhibit a condition where the driver and/or front passenger side seat cushion comes off the seat frame as the customer enters the vehicle.

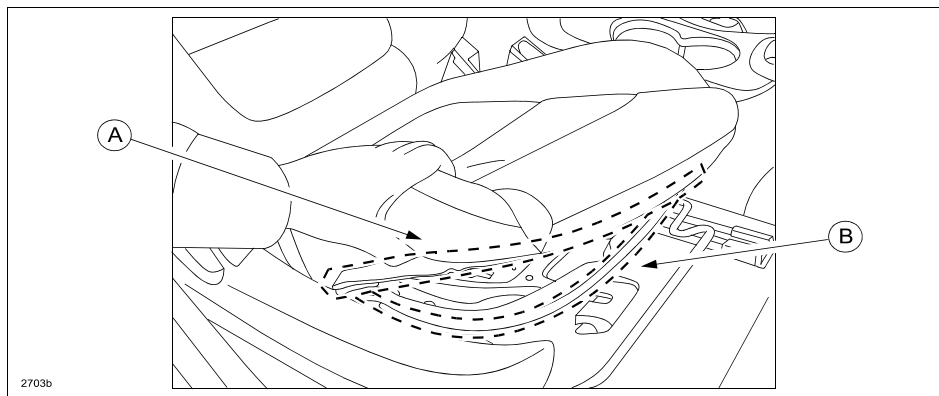
The front seat cushions are attached to the seat frame (B) using folding collars (A). These collars may become loose and slip off the seat frame when force is applied (i.e. customer entry) to the side of the seat cushion.

To eliminate this concern, three (3) clips (per seat) have been installed on the seat frame to increase the grasping force of the folding collars.
