Subject: HOOD VIBRATION WHILE DRIVING AT HIGHWAY SPEED	Bulletin No: 09-029/12
	Last Issued: 07/27/2012

2013 CX-5 vehicles with VINs lower than JM3KE*****120257 (produced before April 18, 2012)

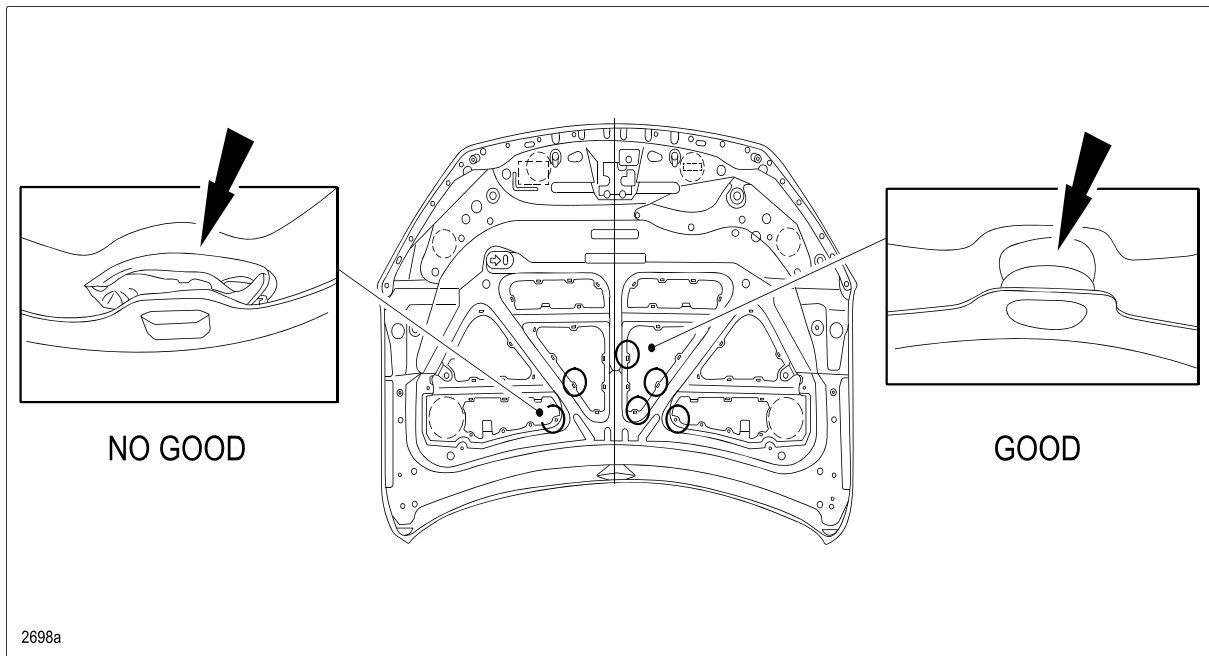
Some vehicles may exhibit a condition where the hood vibrates when driving at speeds of 110 Km/h (68 mph) or more.

The amount of sealant used to fill in the space between the inner frame and outer panel at the bottom area of the hood is insufficient. If the sealant detaches (as shown below on the left), it may cause the hood to vibrate. The amount of sealant has been increased during vehicle production to eliminate the concern.

Customers having this concern should have their vehicle repaired using the following repair procedure.

Additional dampening material will be applied between the hood's inner frame and outer panel and the hood height will be adjusted to apply additional tension.

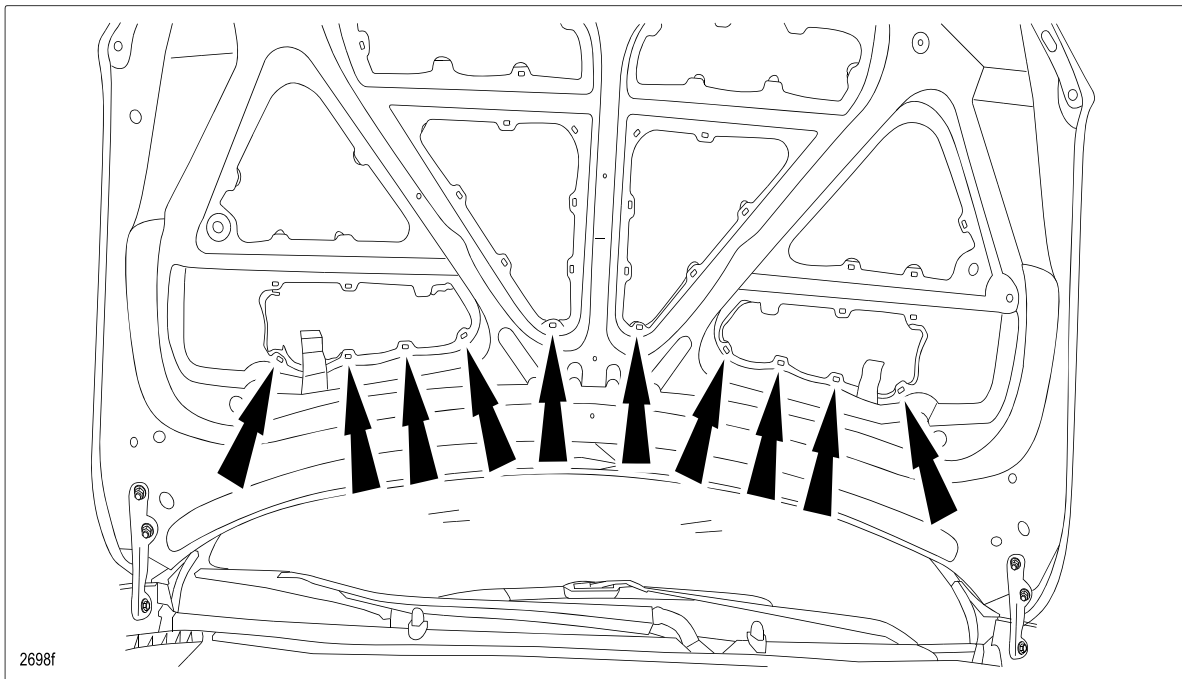
1. Verify the customer concern.
2. Open the hood and secure it with the support rod.
3. Remove the hood insulator according to the MS3 online instructions or the Workshop Manual (section 09-10 HOOD DISASSEMBLY/ASSEMBLY).
4. Confirm the ten (10) original sealant spots at the bottom area of the hood.

- Additional dampening material will be applied **between** these ten (10) original sealant spots.
- It is not necessary to apply dampening material to other areas of the hood. Even if the original sealant has become detached, it will have no influence on the hood vibration concern.
