| <b>Subject:</b><br><br>HORN SOUNDS BY ITSELF | <b>Bulletin No:</b> 09-024/12 |
| | <b>Last Issued:</b> 06/27/2012 |

2013 CX-5 vehicles with VINs lower than JM3KE\*\*\*\*\*110830 (produced February 29, 2012)

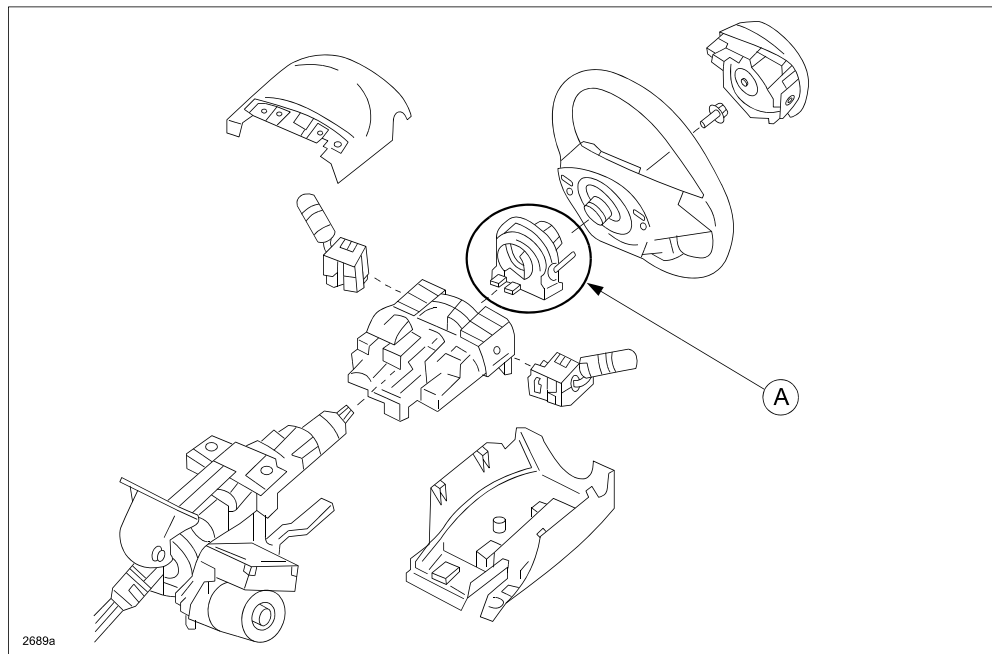
This concern may be caused by an internal short circuit of the clock spring.

1. Verify the customer concern.
2. Inspect the clock spring (A) according to the instructions on MS3 online or the Workshop Manual (section 08-10 CLOCK SPRING INSPECTION [STANDARD DEPLOYMENT CONTROL SYSTEM]) or CLOCK SPRING INSPECTION [TWO-STEP DEPLOYMENT CONTROL SYSTEM]).
  - If any problems are found during the inspection, go to next step.
  - If no problems are found during the inspection, inspect other horn circuits according to MS3 online or the Workshop Manual.

3. Replace the clock spring with a modified part according to the instructions on MS3 online or the Workshop Manual (section 08-10 CLOCK SPRING REMOVAL/INSTALLATION [STANDARD DEPLOYMENT CONTROL SYSTEM]) or CLOCK SPRING REMOVAL/INSTALLATION [TWO-STEP DEPLOYMENT CONTROL SYSTEM]).
4. Verify the repair
