<b>Subject:</b> <b>KNOCKING / RATTLING NOISE FROM PASSENGER SEAT BACK - (MANUAL SEAT ONLY)</b>	<b>Bulletin No:</b> 09-017/12
	<b>Last Issued:</b> 04/20/2012

2013 CX-5 vehicles (equipped with manual seats only) with VINs lower than JM3 KE\*\*\*\*\* 107960 (produced February 14, 2012)

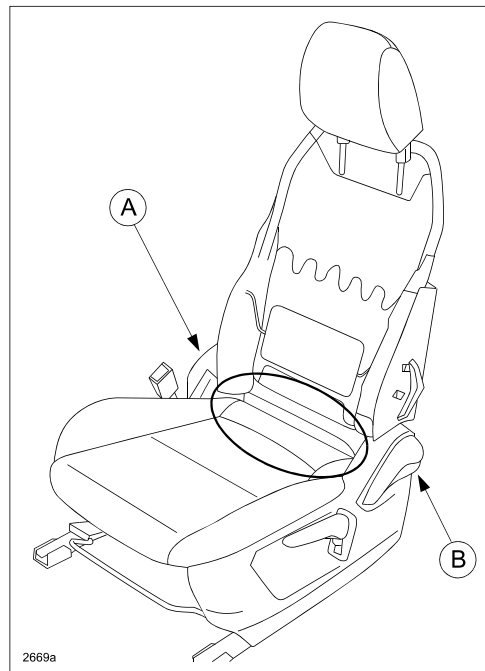
Some vehicles equipped with manual seats may exhibit a knocking or rattling noise from the lower side of the passenger seat back (A) while driving the vehicle.

The noise may be caused by a lack of space between the reclining lever (B) rod and seat back frame. To minimize the movement of the rod, the rod and frame have been tied with a band during production.

Customers having this concern should have their vehicle repaired using the following repair procedure.
