Subject: LIFTGATE OPENER SWITCH INOPERATIVE	Bulletin No: 09-037/12
	Last Issued: 08/31/2012

2013 CX-5 vehicles with VINs lower than JM3KE*****119968 (Produced before April 17, 2012)

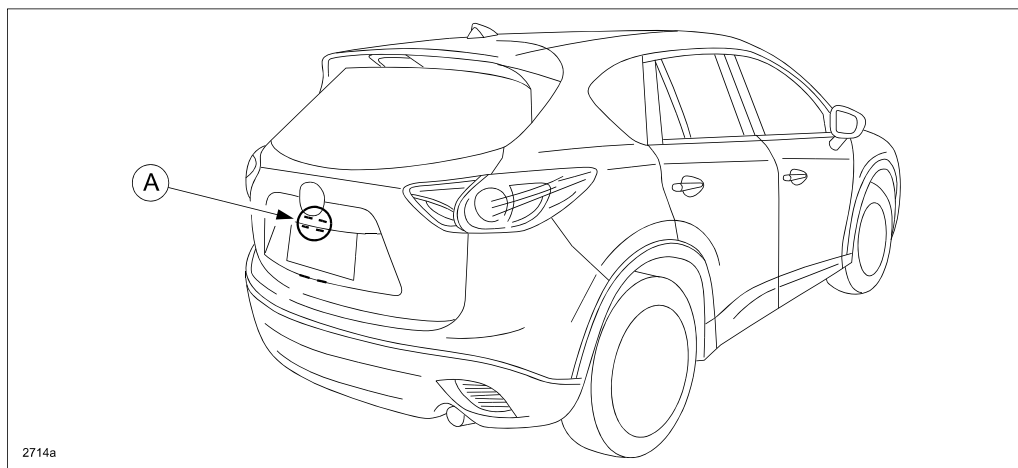
Some vehicles may have a liftgate that does not open when the liftgate opener switch (A) is pushed.

This concern may be due to water entry into the liftgate opener switch connector during a car wash or by other means of condensation. The connector terminals may then become corroded.

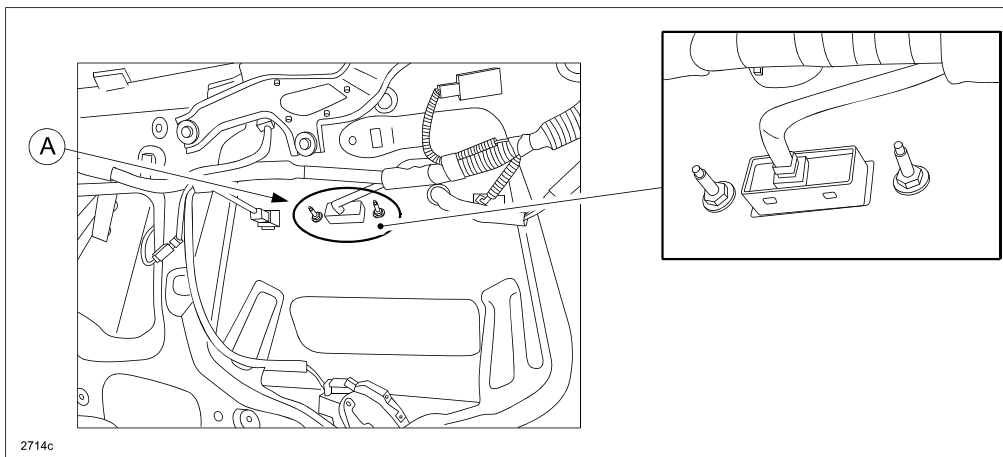
1. Verify the customer concern
2. Remove the liftgate trim according to the MS3 on-line instructions or Workshop Manual (section 09-17 LIFT-GATE LOWER TRIM REMOVAL/INSTALLATION).
3. Disconnect the connector from the liftgate opener switch.
4. Inspect for water intrusion and rust/corrosion on the terminals of the liftgate opener switch connector (A) and the Rear Harness No. 2.

NOTE: NOTE: If there is any rust/corrosion found on the Rear Harness No. 2 connector, replace it.
