Subject: POOR APPEARANCE OF GLOVE COMPARTMENT	Bulletin No: 09-021/12
	Last Issued: 05/23/2012

2013 CX-5 vehicles with VINs lower than JM3KE*****111865 (produced before March 5, 2012)

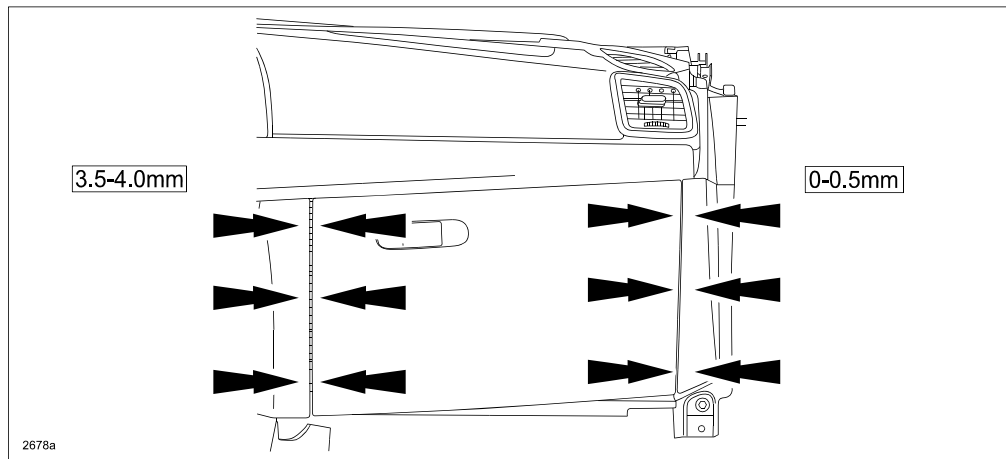
Some vehicles may have a difference in gap clearance (see example shown below) between the left and right sides of the glove compartment, which causes a poor appearance concern. The uneven gaps may be caused by the incorrect tightening order of the lower panel screws.

The tightening order of the lower panel screws has been clearly specified at production to eliminate this concern.

Customers having this concern should have their vehicle repaired using the following repair procedure.
