| Subject: RATTLE NOISE FROM INSTRUMENT PANEL AND/OR CREAK NOISE FROM A-PILLAR OVER ROUGH / BUMPY ROADS | Bulletin No: 09-009/12 |
| | Last Issued: 08/02/2012 |

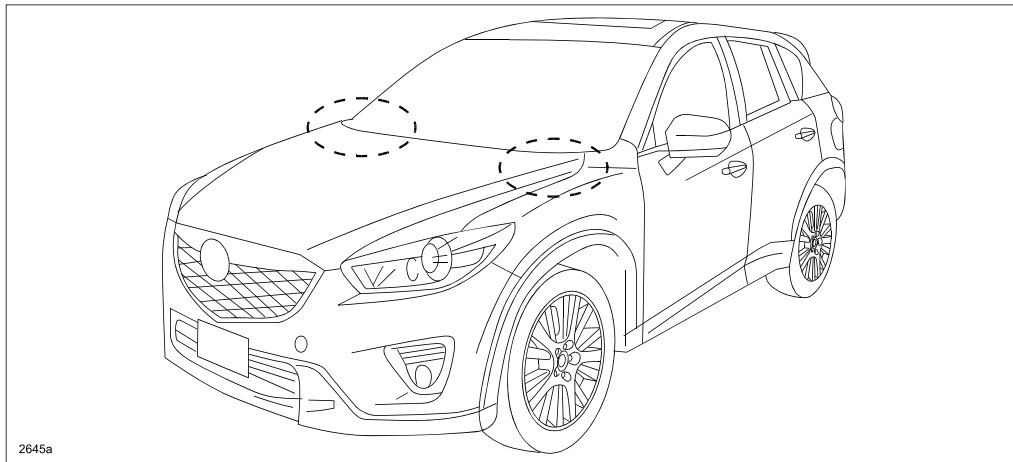
Rattle Noise From Instrument Panel:

While driving over rough or bumpy roads, some vehicles may exhibit a rattle noise from the instrument panel and/or a creak noise from the A-pillar.

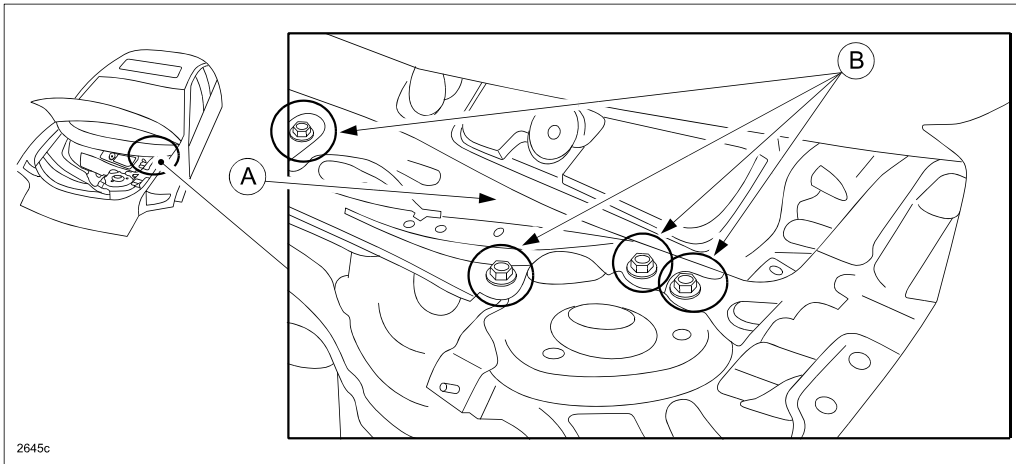
This noise may be caused by low cowl panel (A) mounting bolt (B) torque. The bolt torque control and inspection has been improved during the mass-production of vehicles with VINs JM3KE*****107376 (produced February 10, 2012) or higher.

1. Remove the cowl grille according to the online MS3 instructions or the Workshop Manual (section 09-16 COWL GRILLE REMOVAL/INSTALLATION).

2. Retighten all ten (10) cowl panel bolts (A) to:
Tightening Torque: 17-22 ft. lbs {22-30 Nm, 2.3-3.0 kgf-m}
3. Reinstall the cowl grille according to the online MS3 instructions or the Workshop Manual (section 09-16 COWL GRILLE REMOVAL/INSTALLATION).
4. Proceed to “**Creak Noise From A-Pillar**”.

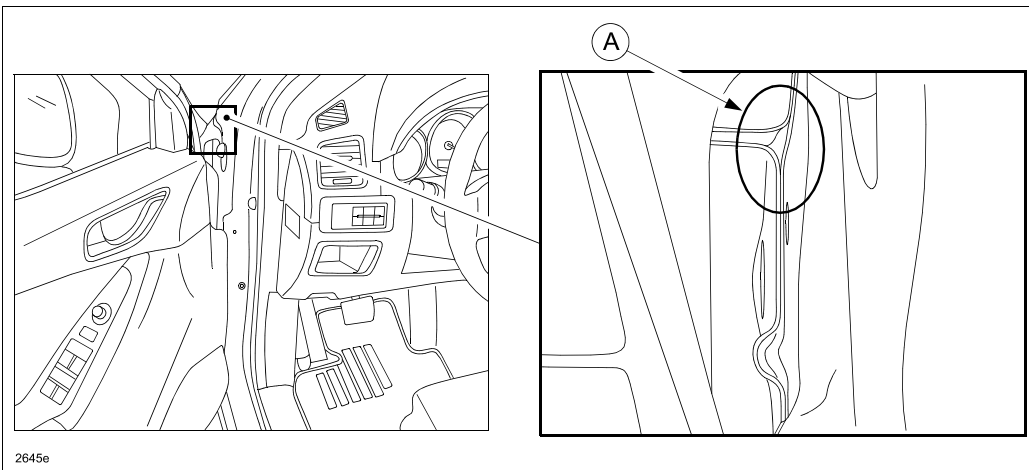
Creak Noise From A-Pillar:

This noise may be caused by two joined panels (A) scraping together at the A-pillar. The panel weld areas have been improved during the mass-production of vehicles with VINs JM3KE*****128359 (produced June 1, 2012) or higher.
