Subject: RATTLING NOISE FROM LIFTGATE WHEN GOING OVER A BUMP	Bulletin No: 09-031/12
	Last Issued: 08/02/2012

2013 CX-5

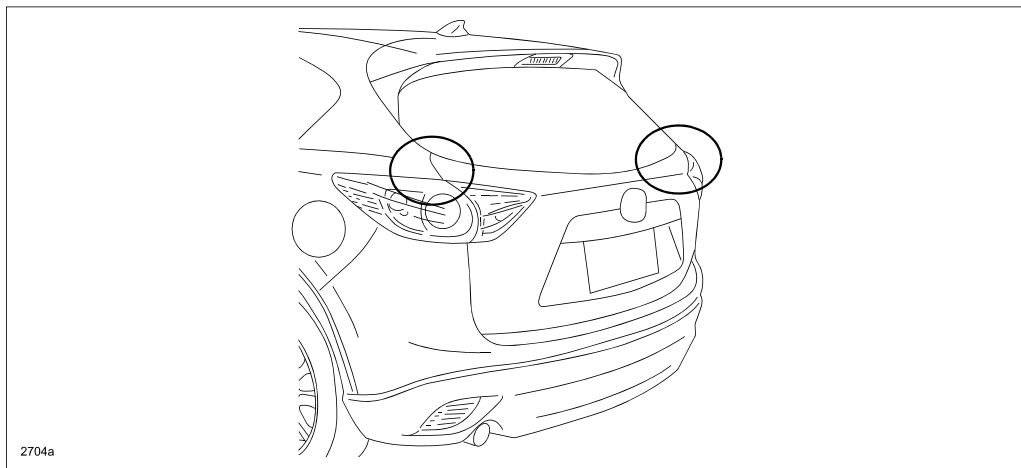
Some vehicles may exhibit a rattling noise from the liftgate when going over a bump. The noise may be caused by an incorrect liftgate adjustment tolerance.
