Subject: REAR CENTER SEAT BRACKET COVER COMES OFF	Bulletin No: 09-032/12
	Last Issued: 08/08/2012

2013 CX-5 vehicles equipped with a 4:2:4 split type rear seat with VINs lower than JM3KE*****140972 (produced before Aug. 1, 2012)

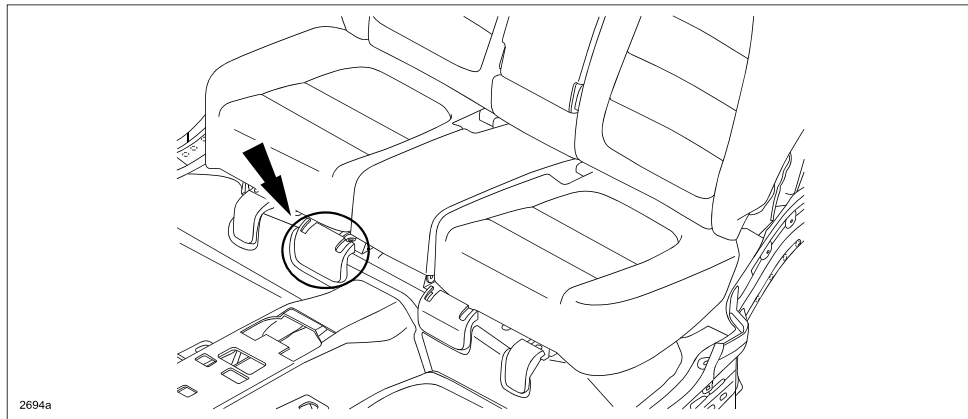
Some vehicles equipped with a 4:2:4 split type rear seat may notice the right-side bracket cover from the rear center seat comes off. This only occurs with the right-side bracket cover, not the left-side bracket cover.

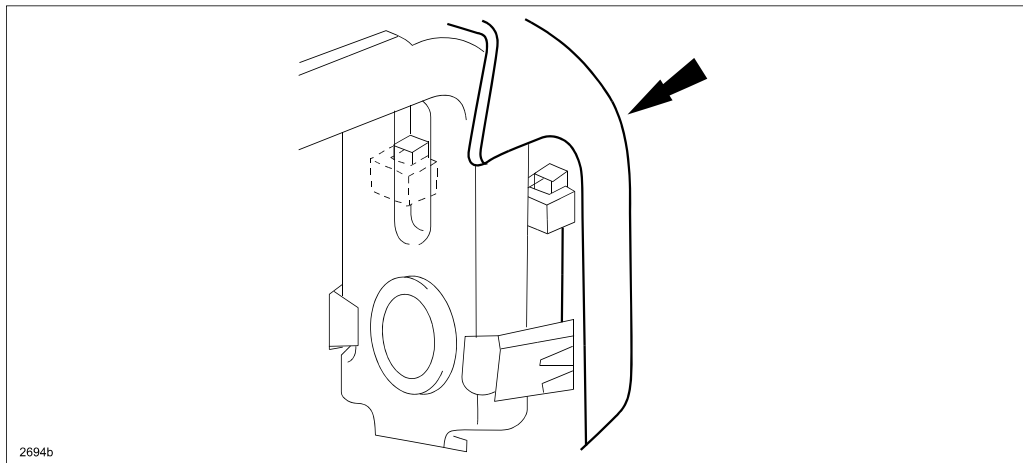
This concern may be caused by the lower edge of the bracket cover hitting the floor carpet when the cover has not been properly installed.

Customers having this concern should have their vehicle repaired using the following repair procedure.
