Service Information

Category S	Repair Guidance	Ref. No. R002/13	Page 1 of 5
Coverage <input type="checkbox"/> Distributor only <input checked="" type="checkbox"/> Please inform your dealers		Date Issued January 16, 2013	
Please convey this information to your <input type="checkbox"/> Director <input checked="" type="checkbox"/> General Manager <input checked="" type="checkbox"/> Warranty Dept. <input checked="" type="checkbox"/> Parts Dept. <input checked="" type="checkbox"/> Training Dept. <input checked="" type="checkbox"/> Field Rep.		Date Revised	
Applicable Model Mazda6 (GJ)		Applicable Countries or Specifications Worldwide

Subject: Right side of front bumper is lifted up from fender

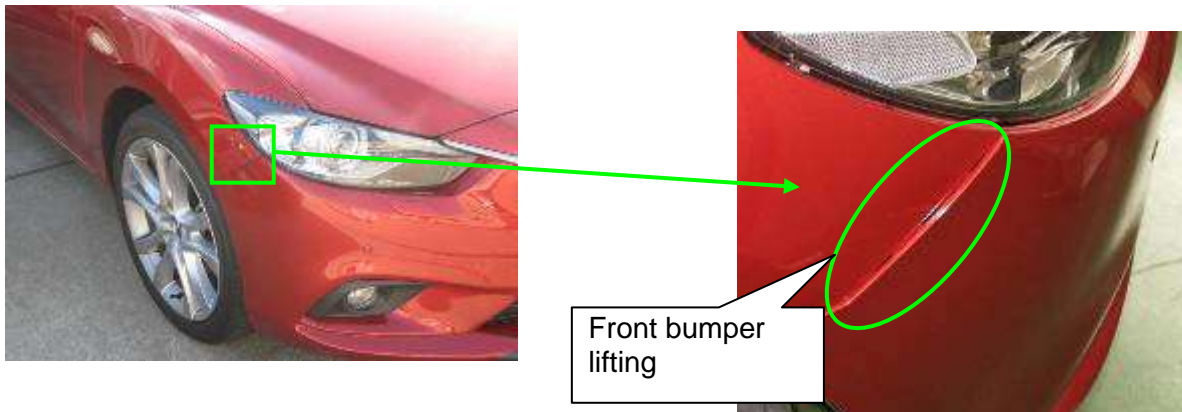
If the front bumper is removed and installed repeatedly for instance to install accessories, the right side of front bumper may lift up from the front fender when the vehicle is driven. Even after the front bumper is pushed back in the original position, it may reoccur.

Engagement force between the front bumper and bumper retainer drops down due to repeated removal/installation of the front bumper.

Install a piece of hard sponge at the front side tab of bumper retainer to maintain the engagement force according to the following procedure.

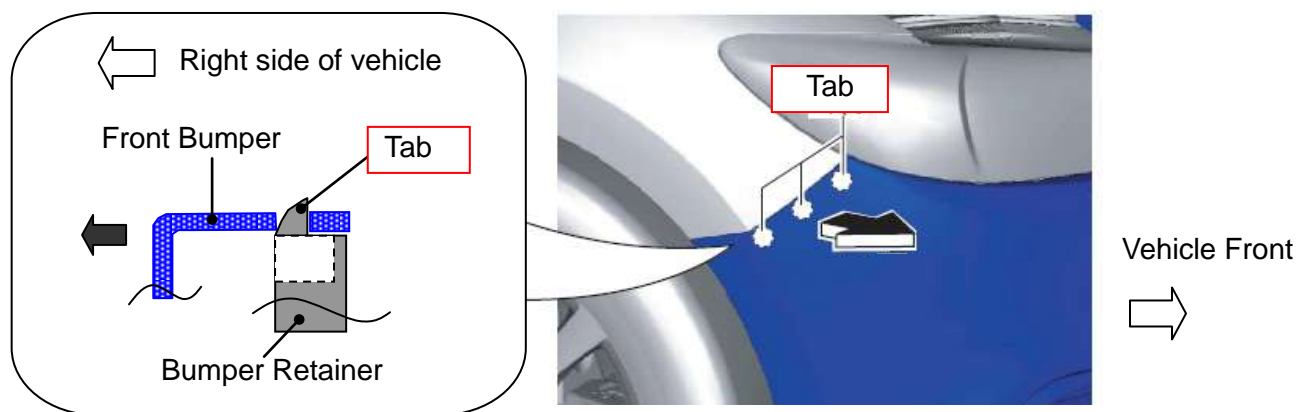
Note: The front bumper and bumper retainer are engaged firmly. If they are disengaged forcibly the bumper could fail and gets damaged.

6. Pull the edge of the front bumper in the direction of arrow in the figure then remove the front bumper out of the 3 tabs from the bumper retainer.
