<b>Subject:</b>  SHIFT SHOCK	<b>Bulletin No:</b> 05-004/12
	<b>Last Issued:</b> 11/1/2012

## BULLETIN NOTE

2012-2013 Mazda3 (SKYACTIV-G and A/T) with VINs lower than JM1BL\*\*\*\*\*702072 (produced before July 25, 2012)

2013 CX-5 (A/T) with VINs lower than JM3KE\*\*\*\*\*139311 (produced before July 25, 2012)

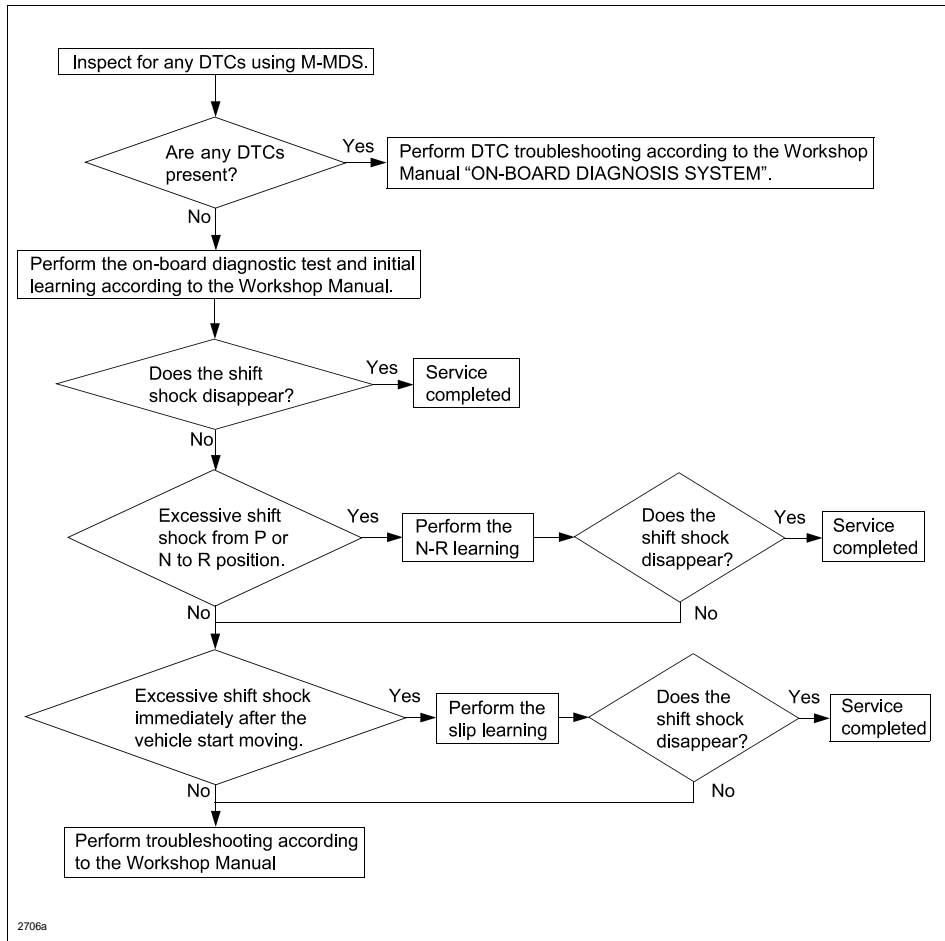
**Diagnosis Flowchart**

Some vehicles may experience an excessive shift shock at one or more of the following conditions:

- When shifting from P to R position or N to R position.
- When the transmission shifts immediately after starting to move (in D position).
- When the transmission shifts at cruising speed (in D position).

The initial learning may not have been completed at the time of vehicle production. To correct the problem, one or more learning procedures may need to be performed.

1. Verify customer concern.
2. Follow the Diagnosis Flowchart on the following page and perform the N-R and/or Slip Learning Procedure.
3. Verify repair.

1. Verify the ATF temperature reached 60°C (140°F) or over.
2. Shift the selector lever from N to R position and wait for 5 seconds
3. Shift the selector lever from R to N position and wait for 5 seconds
4. Repeat steps 2 to 3 ten times.

1. Verify the ATF temperature reached 20°C (68°F) or over (\*1).
2. Drive the vehicle until upshifting from 1st to 2nd gear occurs at each of the following accelerator pedal position (APP) percentages: 20%, 40%, 60%. Monitor the APP PID using M-MDS and come to a complete stop before moving to the next one.
