Subject: SQUEAK NOISE FROM ENGINE COMPARTMENT	Bulletin No: 01-021/12
	Last Issued: 11/28/2012

2010-2013 Mazda3 (including 2.0L SKYACTIV)

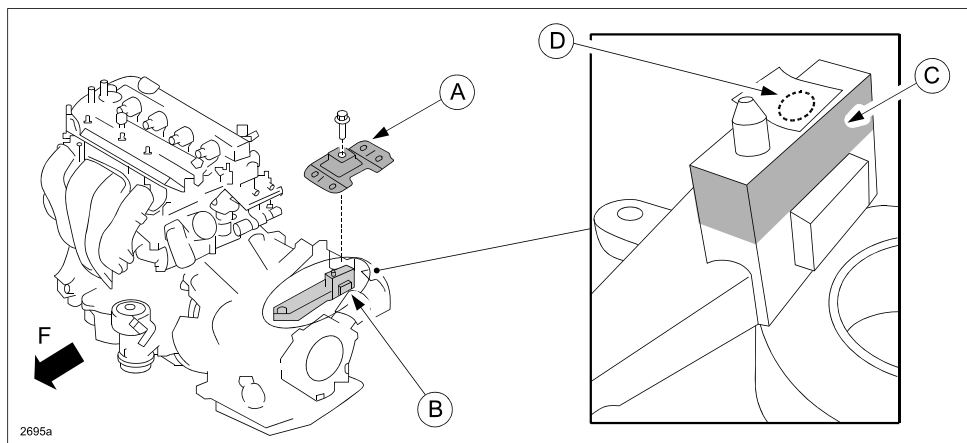
Some vehicles may exhibit a squeak noise from the engine compartment when the vehicle starts moving and/or at the time of transmission shifting. This is caused by stick-slip noise occurring at the contact surfaces between the No. 4 engine mount rubber and the No. 4 engine mount bracket when the engine shakes back and forth. To correct the problem, the No. 4 engine mount is replaced and grease is applied on the contact surfaces of the No. 4 engine mount bracket.

1. Verify customer concern.
2. Remove the No. 4 engine mount rubber (A) from the No. 4 engine mount bracket (B). Refer to MS3 online instructions or Workshop manual section 09-20 ENGINE REMOVAL/INSTALLATION.
