Subject: STAINS FOUND ON PAINT DURING PDI	Bulletin No: 09-011/12
	Last Issued: 03/12/2012

BULLETIN NOTE

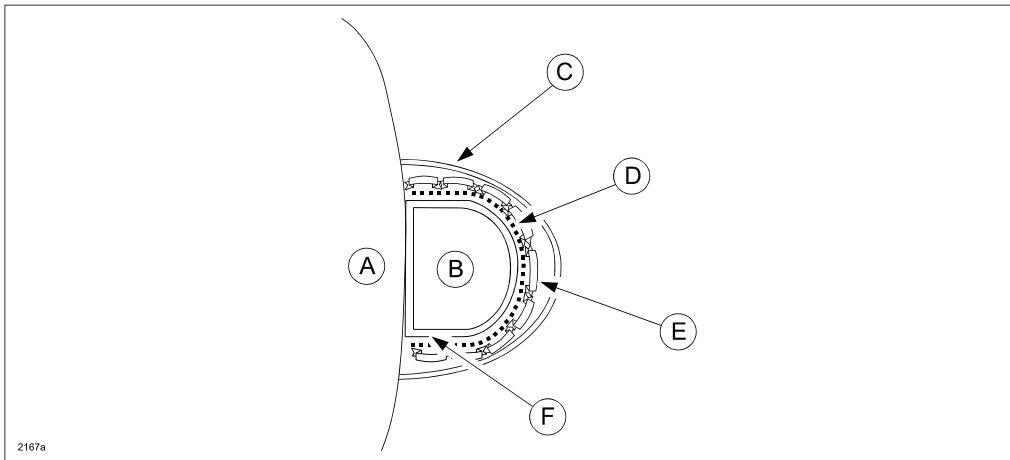
- A - Body Panel
- B - Molding
- C - Aluminum foil covering all area
- D - Wet towel
- E - Folded aluminum foil
- F - Aluminum foil tape

1. Visually inspect the top coat surface for stains.
 - If stains are found, use a heat gun (for smaller stains) or an infrared drier (for larger stains) to heat the affected area and remove the stains.
2. Insulate all plastic and rubber parts (as shown below) using heat insulation materials (C ~ F) prior to beginning the application of heat.

- Since this repair procedure requires the use of heat from a heat gun or infrared drier, be sure to insulate all rubber or plastic parts which are easily affected by heat from near the affected stain area.
- Use extreme care to ensure the top coat surface temperature stays below 284°F (140°C).
- To protect materials inside the cabin area (i.e. carpet, seats, etc.), also place insulation over the glass as necessary.
