<b>Subject:</b>  TAPPING NOISE COMING FROM FRONT SEAT BACK	<b>Bulletin No:</b> 09-030/12
	<b>Last Issued:</b> 08/02/2012

2013 CX-5 vehicles with VINs lower than JM3KE\*\*\*\*\*116881 (Produced before April 4, 2012)

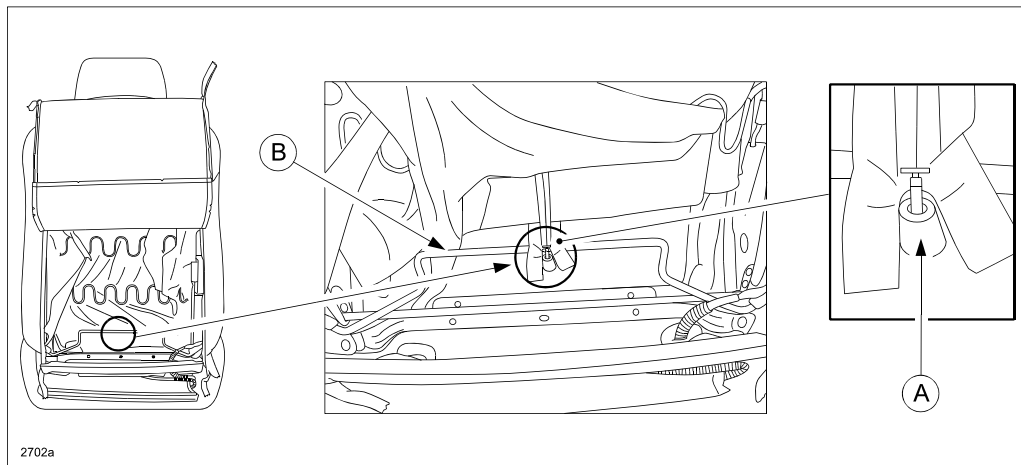
Some vehicles may exhibit a tapping noise from inside the front seat back while driving on rough road surfaces. The seat may also shake during rapid vehicle acceleration or deceleration. This concern may be caused by contact between the plastic slider (A) and seat rod (B).

To eliminate this concern, a piece of urethane has been attached to the center of the seat rod to prevent contact with the slider.
