Subject: TAPPING NOISE WHERE EDGE OF DASHBOARD MEETS WINDSHIELD	Bulletin No: 09-004/13
	Last Issued: 03/06/2013

2013 CX-5 vehicles with VINs JM3KE*****122583 ~ 146712 (produced May 6, 2012 ~ Aug. 31, 2012)

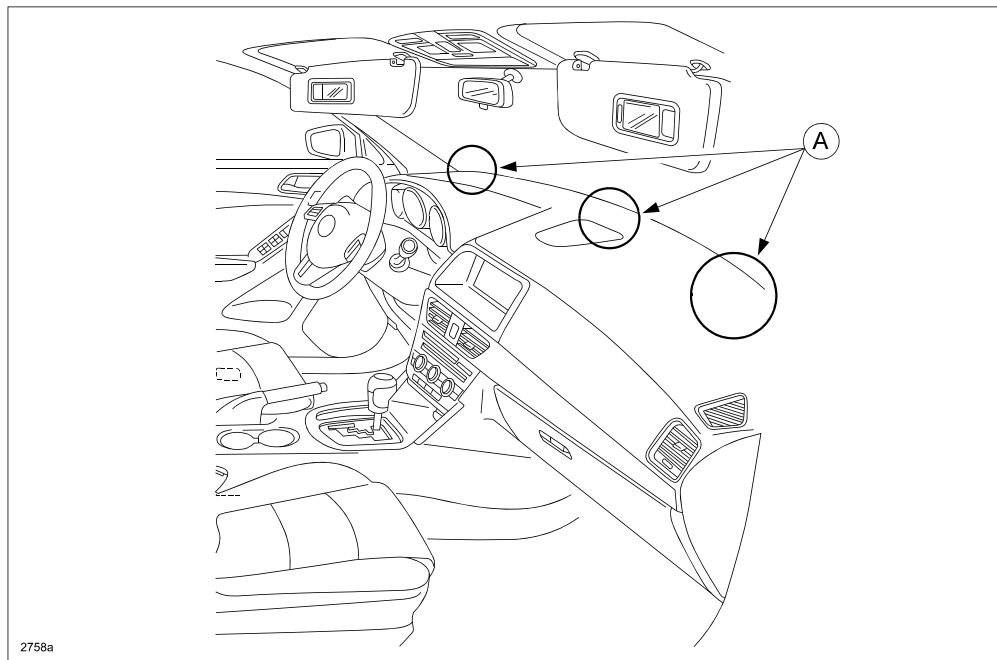
Some vehicles may exhibit a tapping noise which is audible from the front edge of the dashboard (A) (where it meets the base of the windshield) when driving over bumps or rough roads.

The tapping noise may be caused when the front edge of the dashboard contacts the body-side bracket(s). To eliminate the noise, felt pads have been attached to all (3) three body-side brackets during vehicle mass-production.

Customers having this concern should have their vehicle repaired using the following repair procedure.

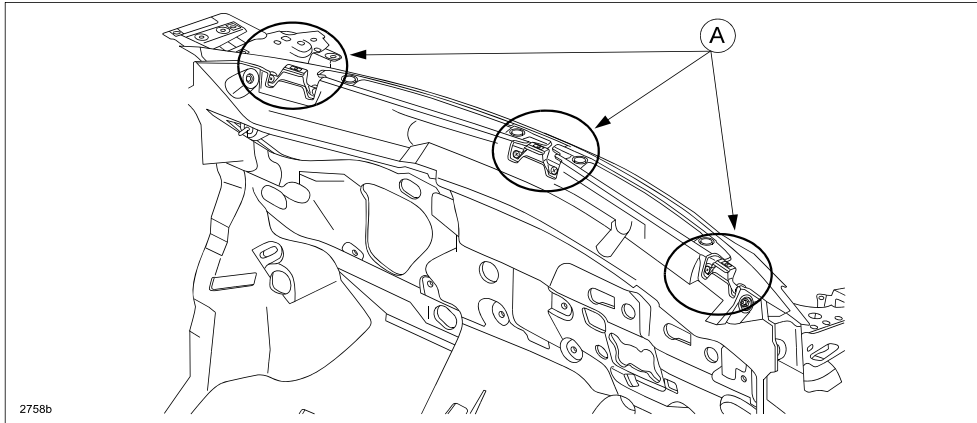
There are (3) three brackets (left, center and right) on the body-side as shown below (A). A felt pad is attached to each bracket for noise prevention. However, depending on the VIN and production date of the vehicle, felt pads may or may not have been attached to all three brackets. Vehicles without felt pads may experience a tapping noise when driving over bumps or rough roads.

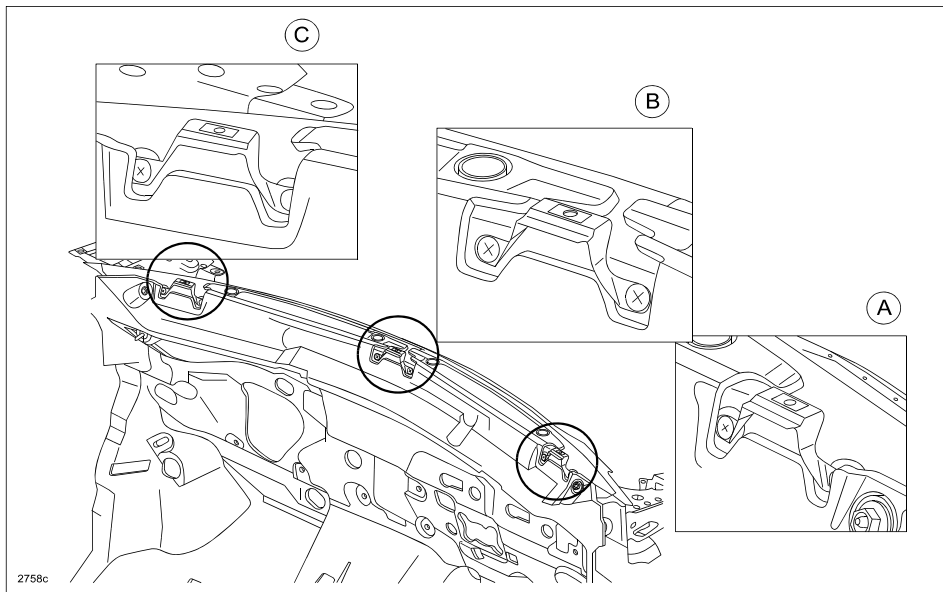
Production date ranges for vehicles with and without felt pads: O = with felt pads, X = without felt pads.
