<b>Subject:</b>  <b>UNUSUAL ENGINE NOISE AFTER A COLD ENGINE START</b>	<b>Bulletin No:</b> 01-006/13
	<b>Last Issued:</b> 02/13/2013

2013-2014 CX-5

2014 Mazda6

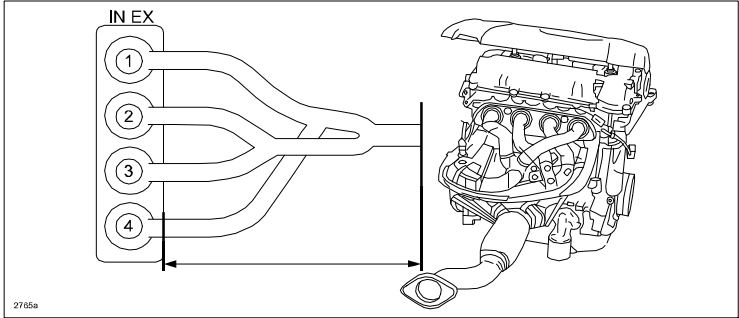
The SKYACTIV-G engine is equipped with 4-2-1 exhaust manifold to improve the fuel economy and engine power. The distance from the engine to the catalytic converter is longer than previous engines such as the LF engine. This longer distance does not allow the catalytic converter to warm up quickly. To off-set this condition, AWS has been developed by burning fuel inside the exhaust manifold for 20 seconds to quickly warm up the catalytic converter. The customer may identify the burning sound as an unusual noise.

SKYACTIV-G	<p><b>Long Exhaust Pipes (4-2-1 Type)</b></p>

LF Engine	<p><b>Short Exhaust Pipes</b></p>

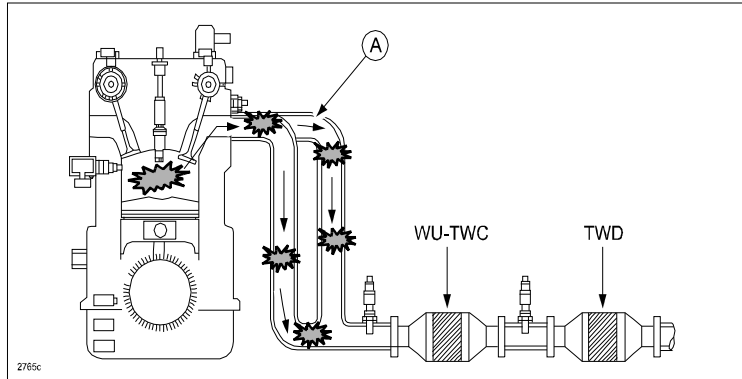
AWS burns fuel inside the exhaust manifold (A) to quickly warm up the catalytic converter. The customer may identify the burning sound as an unusual noise.
