Service Information

Category S	Repair Guidance	Ref. No. R021/13	Page 1 of 6
Coverage <input type="checkbox"/> Distributor only <input checked="" type="checkbox"/> Please inform your dealers		Date Issued March 13, 2013	
Please convey this information to your <input type="checkbox"/> Director <input checked="" type="checkbox"/> General Manager <input checked="" type="checkbox"/> Warranty Dept. <input checked="" type="checkbox"/> Parts Dept. <input checked="" type="checkbox"/> Training Dept. <input checked="" type="checkbox"/> Field Rep.		Date Revised	
Applicable Model Mazda6 (GJ)		Applicable Countries or Specifications Worldwide

Subject: Rattle Noise from Passenger side Instrument Panel

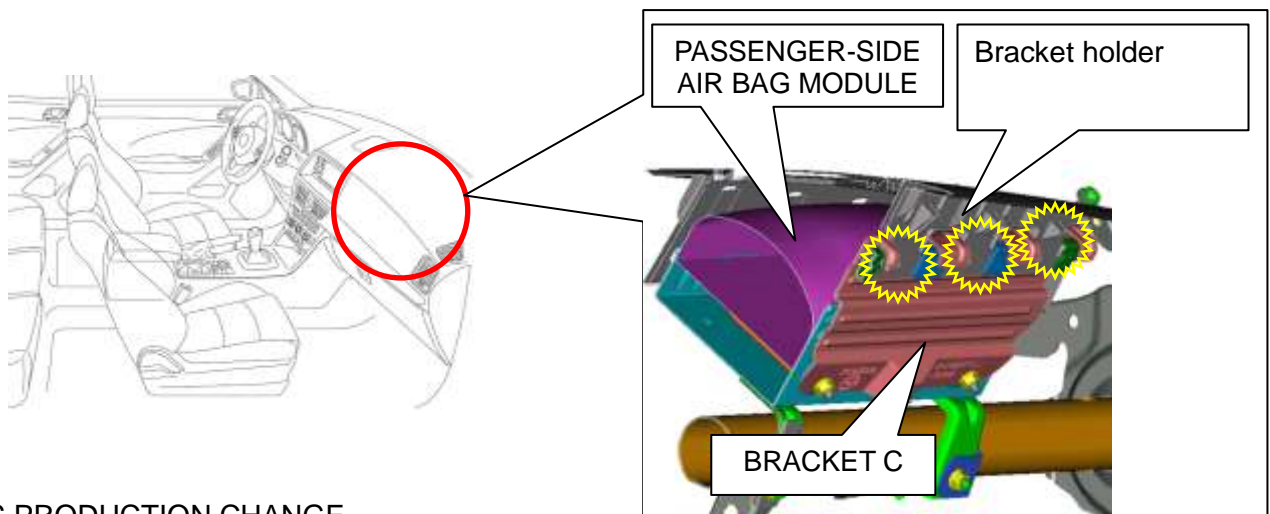
The bracket C on the passenger-side air bag and bracket holder on the instrument panel interfere and make a rattle noise when driving on a rough road.

The felt size and attaching point on the bracket holder have been changed.
