Service Information

Category B	Repair Gui	dance	Ref. No. R003/13A	Page 1 of 5
Coverage ☐ Distributor only ☐ Please inform your dealers			Date Issued January 17, 2013	
Please convey this information to your ☐ Director ☐ General Manager ☐ Warranty Dept. ☐ Parts Dept. ☐ Training Dept. ☐ Field Rep.		Date Revised March 13, 2013		
Applicable Model		Applicable Countries or Specifications		
Mazda6(GJ) with SKYACTIV-D 2.2		Australia, New Zealand and Europe.

Subject: Clinking/Hissing noise from the front right side of vehicle

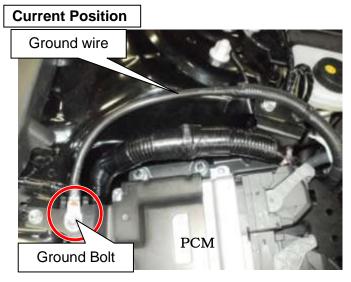
The engine noise is transferred and amplified by the ground wire. Then the noise can be heard from the front right side of vehicle.

Change the installation location of ground harness using a heat-resisting tape (PVC Tape). After that, conduct the fuel injection amount correction using Mazda Modular Diagnostic System (M-MDS)
