Service Information

Category S	Repair Guidance	Ref. No. R022/13	Page 1 of 2
Coverage <input type="checkbox"/> Distributor only <input checked="" type="checkbox"/> Please inform your dealers		Date Issued March 13, 2013	
Please convey this information to your <input type="checkbox"/> Director <input checked="" type="checkbox"/> General Manager <input checked="" type="checkbox"/> Warranty Dept. <input checked="" type="checkbox"/> Parts Dept. <input checked="" type="checkbox"/> Training Dept. <input checked="" type="checkbox"/> Field Rep.		Date Revised	
Applicable Model CX-5 (KE)		Applicable Countries or Specifications Worldwide

Subject: Noise from Front Door Checker Installation Location

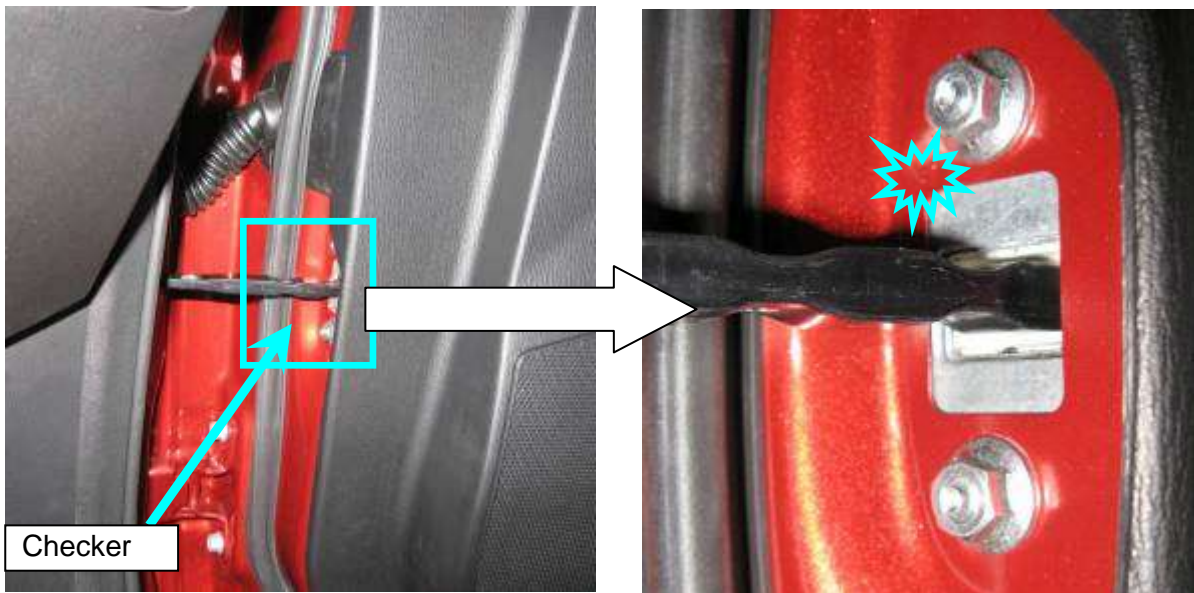
Some vehicles may experience noise from front door checker installation location when opening front door.

When the door is fully opened, the door checker is over stroked which causes a crack at the spot welding area around the door checker. Then the noise occurs when door is opened.
