Service Information

Category S	Repair Guidance		Ref. No. R020/13	Page 1 of 7
Coverage ☐ Distributor only ■ Please inform your dealers			Date Issued March 13, 2013	
Please convey this information to your ☐ Director ☐ General Manager ☐ Warranty Dept. ☐ Parts Dept. ☐ Training Dept. ☐ Field Rep.		o .	Date Revised	
Applicable Model		Applicable Countries or Specifications		
CX-5(KE)		Worldwide

Subject: Outer mirror base cover discolors to white

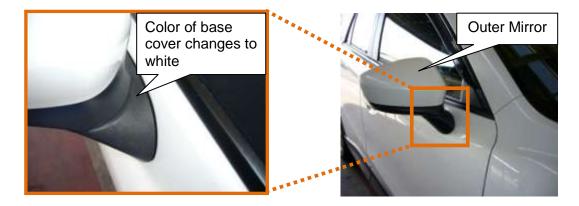
Some vehicles may experience that color of the outer mirror base cover changes to white.

The discolored area contains more glass fiber compared to other area. If this area was grinded by any reason, the glass fibers are exposed and it looks that it discolors to white.

The material of mirror base cover has been changed.

If this concern has occurred on one side, please change the both sides of mirror base cover to modified one.
