Service Information

Category B	Repair Guidance	Ref. No. R003/13 B	Page 1 of 5
Coverage <input type="checkbox"/> Distributor only <input checked="" type="checkbox"/> Please inform your dealers		Date Issued January 17, 2013	
Please convey this information to your <input type="checkbox"/> Director <input checked="" type="checkbox"/> General Manager <input checked="" type="checkbox"/> Warranty Dept. <input checked="" type="checkbox"/> Parts Dept. <input checked="" type="checkbox"/> Training Dept. <input checked="" type="checkbox"/> Field Rep.		Date Revised April 10, 2013	
Applicable Model Mazda6(GJ) with SKYACTIV-D 2.2	Applicable Countries or Specifications Australia, New Zealand and Europe.

Subject: Clinking/Hissing noise from the front right side of vehicle

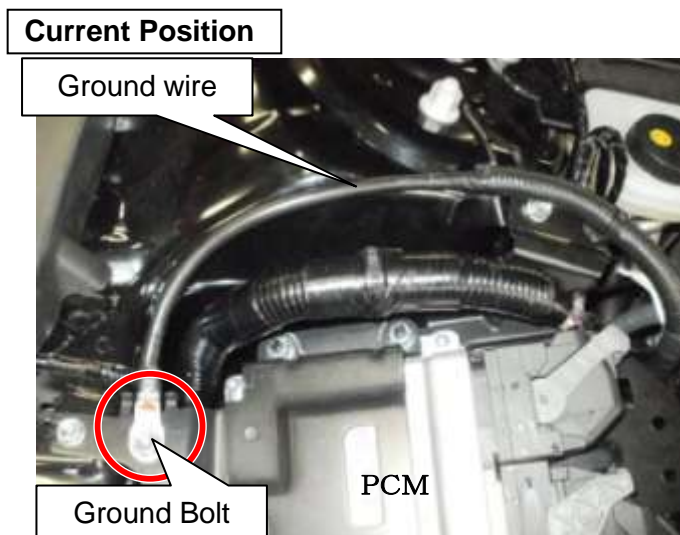
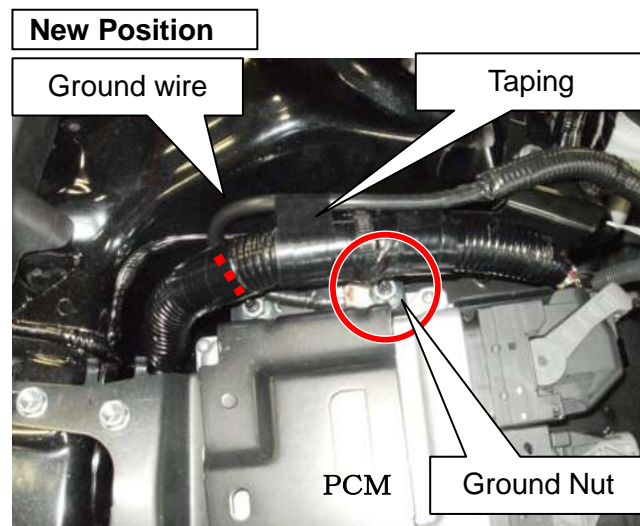
The engine noise is transferred and amplified by the ground wire. Then the noise can be heard from the front right side of vehicle.

Change the installation location of ground harness using a heat-resisting tape (PVC Tape).
