# Service Information

Category <b>S</b>	<b>Repair Guidance</b>	Ref. No. R016/13A	Page 1 of 3
Coverage <input type="checkbox"/> Distributor only <input checked="" type="checkbox"/> Please inform your dealers		Date Issued February 22, 2013	
Please convey this information to your <input type="checkbox"/> Director <input checked="" type="checkbox"/> General Manager <input checked="" type="checkbox"/> Warranty Dept. <input checked="" type="checkbox"/> Parts Dept. <input checked="" type="checkbox"/> Training Dept. <input checked="" type="checkbox"/> Field Rep.		Date Revised April 24, 2013	
Applicable Model  CX-5 (KE)		Applicable Countries or Specifications  Worldwide

## Subject: Wind Noise from Rear Door while driving at 40 km/h

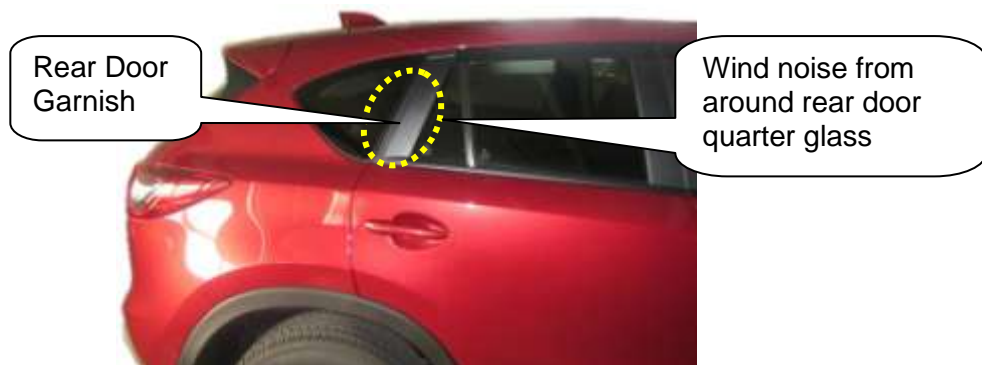
Some customers may complain about a wind noise occurring from around the rear door quarter glass while driving around 40Km/h. In case you receive such a complaint repair the vehicle according to the following repair procedure.

The noise is caused by a gap between the rear door quarter glass and the rear door garnish.

A pad has been attached on the rear door quarter glass guide.
