Category F	M-tips	Ref. No. MME/GJ01/13	Page 1 of 2
Model: Mazda6 (GJ)		Date Issued April 30, 2013	Date Revised
Subject: DTC U0121 (ABS/DSC control module communication failure) stored during PCM reprogramming		Applicable Countries or Specification Europe

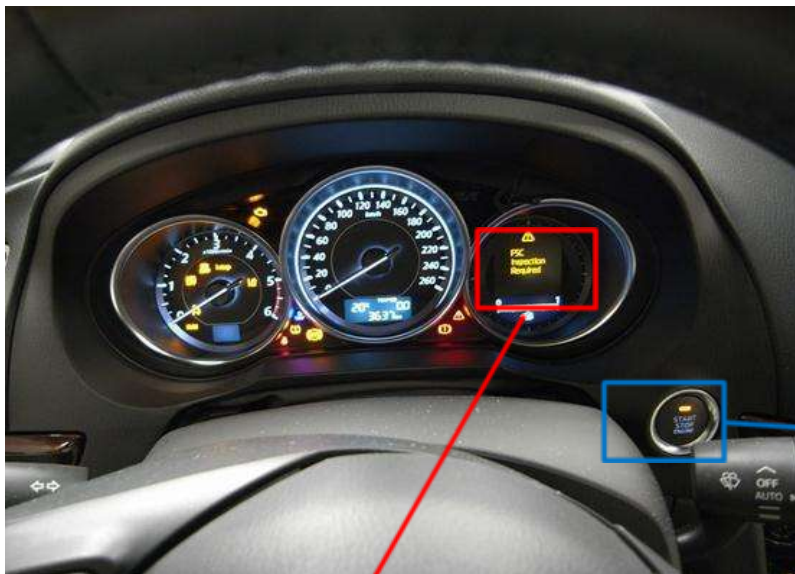
During PCM reprogramming, some vehicles may show some warning messages with flashing Start stop switch. This is caused by reset function of ABS/DSC CU not working properly.

Start Stop switch light flashes.

1. Turn the IG-off by pushing Start Stop switch for long time (around 3 seconds) to turn off.
2. After that, disconnect **ABS/DSC S 30A** Fuse for 30 seconds so that the system is reset back to normal.

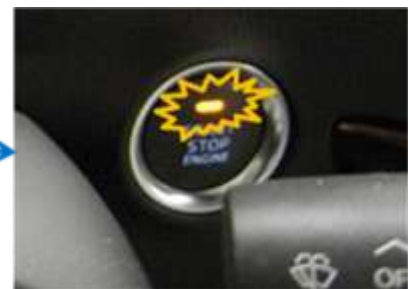
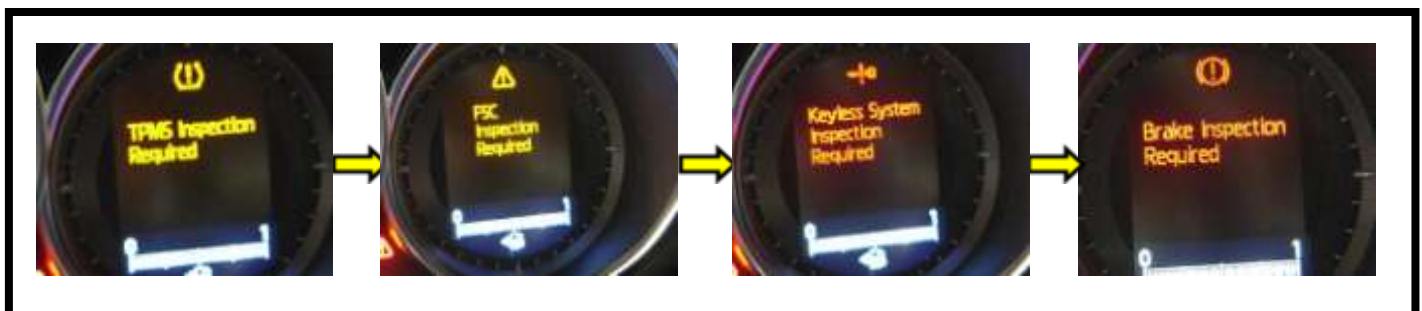
Below warning messages are displayed.

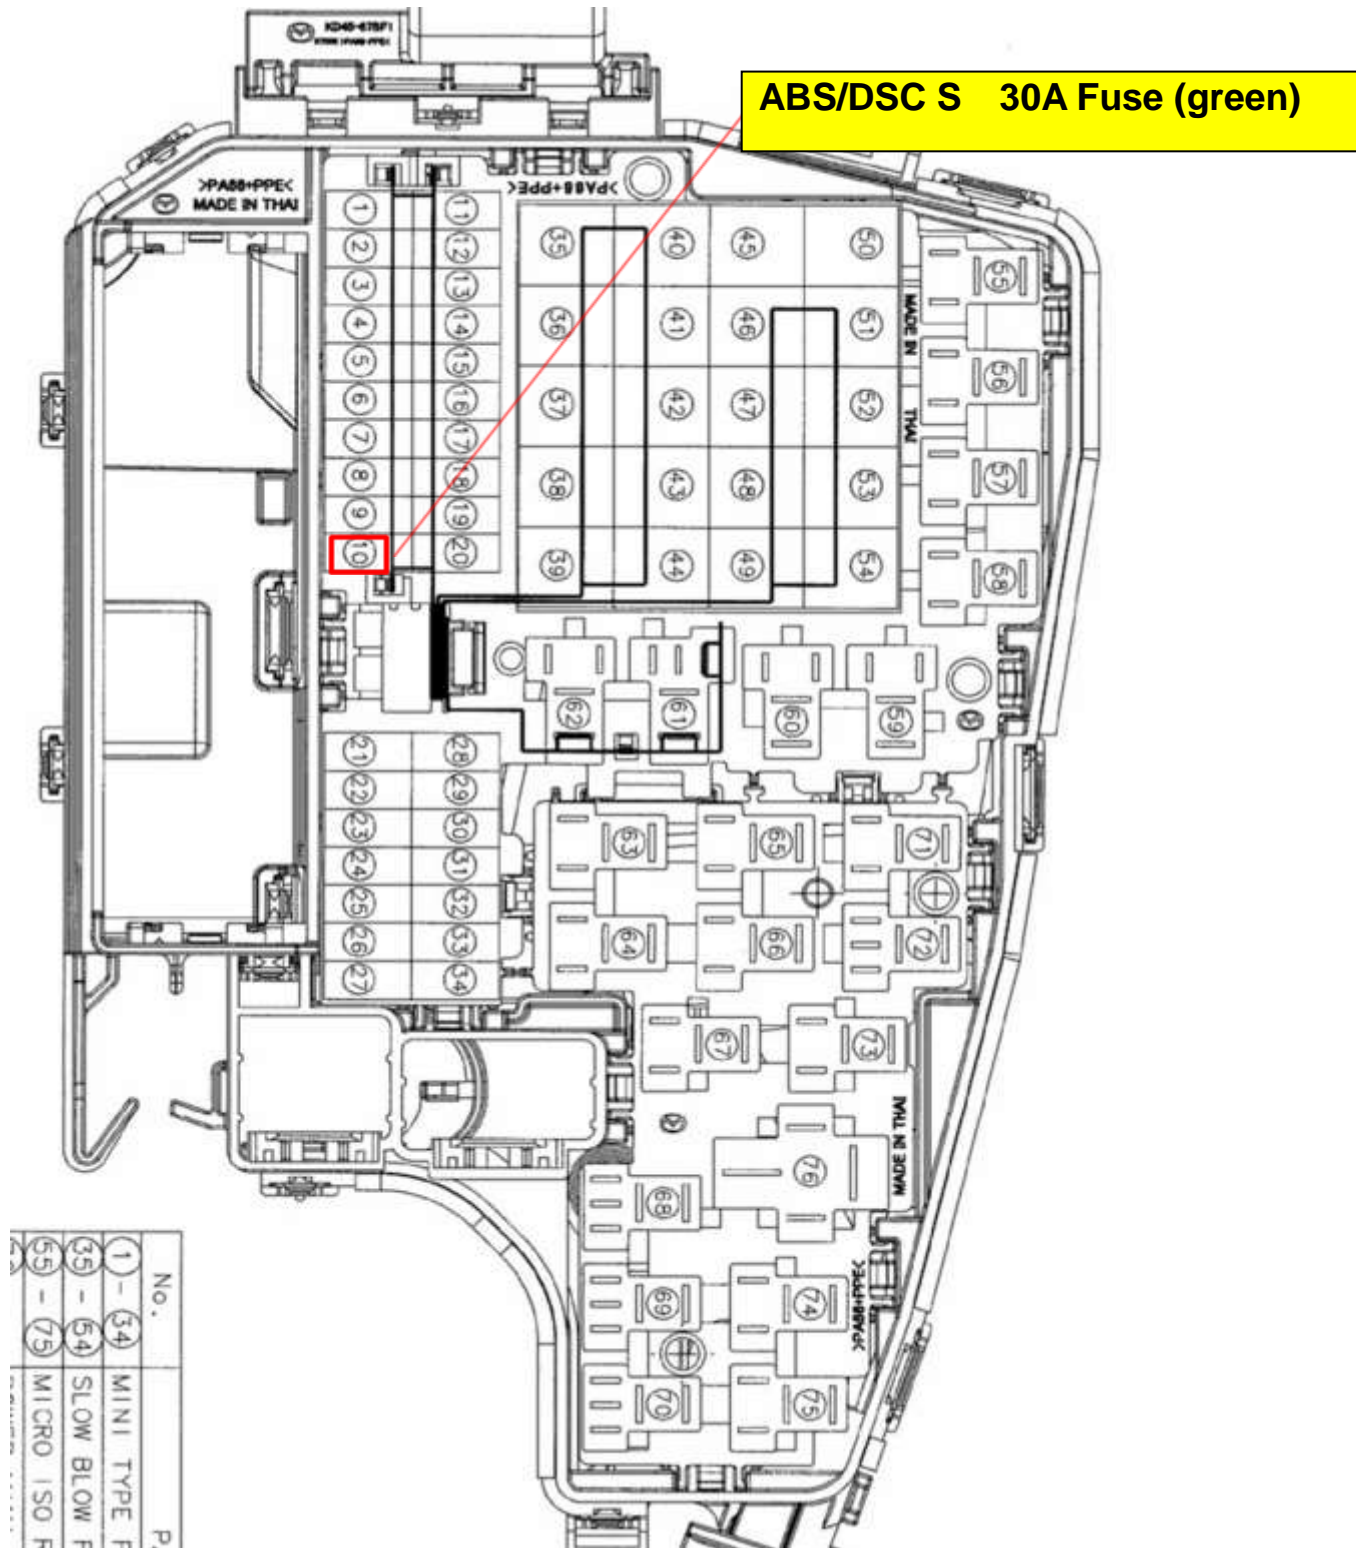
Note: There is similar name fuse "ABS/DSC M 50A, that's wrong one.
