# Service Information

Category <b>S</b>	<b>Repair Guidance</b>	Ref. No. R032/13	Page 1 of 2
Coverage <input type="checkbox"/> Distributor only <input checked="" type="checkbox"/> Please inform your dealers		Date Issued April 24, 2013	
Please convey this information to your <input type="checkbox"/> Director <input checked="" type="checkbox"/> General Manager <input checked="" type="checkbox"/> Warranty Dept. <input checked="" type="checkbox"/> Parts Dept. <input checked="" type="checkbox"/> Training Dept. <input checked="" type="checkbox"/> Field Rep.		Date Revised	
Applicable Model  Mazda6 (GJ)		Applicable Countries or Specifications  Europe, North America

## Subject: Rear Door Lock Inoperative due to Freeze

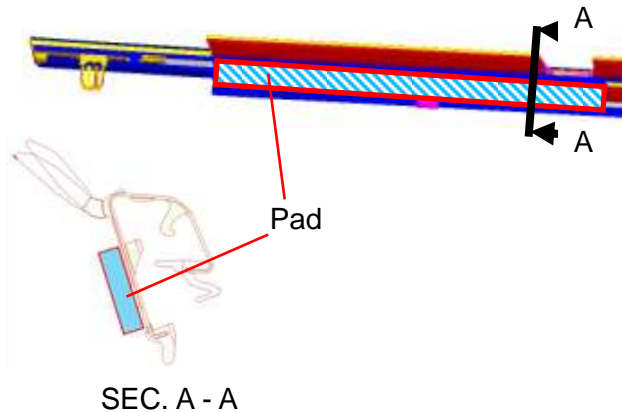
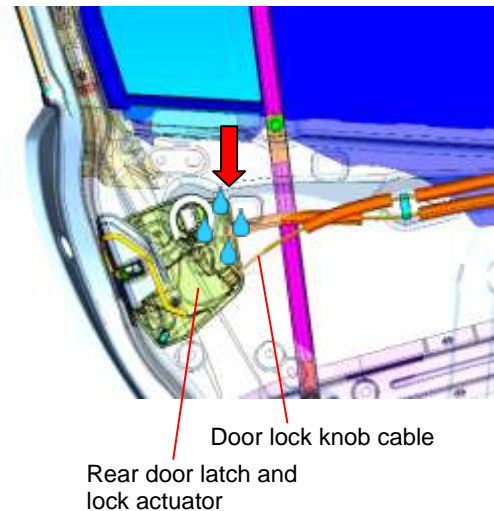
Water enters inside "rear door latch and lock actuator", then gets frozen and stuck at internal link.

The pad of the rear beltline molding has been added.

When you encounter a customer complaint on this concern, eliminate the water around the rear door latch and lock actuator, then replace the rear beltline molding with a modified one according to the following procedure.

1. Remove the rear door trim. Refer to workshop manual REAR DOOR TRIM REMOVAL/INSTALLATION.
2. Remove service hole cover No.1. Refer to workshop manual REAR DOOR LATCH AND LOCK ACTUATOR REMOVAL/INSTALLATION.
3. Eliminate the water from the rear door latch and lock actuator and/or the door lock knob cable by air tool.
4. Replace the rear beltline molding with a modified one
5. Install in the reverse order of removal.
