# Service Information

Category <b>S</b>	<b>Repair Guidance</b>	Ref. No. R027/13A	Page 1 of 4
Coverage <input type="checkbox"/> Distributor only <input checked="" type="checkbox"/> Please inform your dealers		Date Issued April 4, 2013	
Please convey this information to your <input type="checkbox"/> Director <input checked="" type="checkbox"/> General Manager <input checked="" type="checkbox"/> Warranty Dept. <input checked="" type="checkbox"/> Parts Dept. <input checked="" type="checkbox"/> Training Dept. <input checked="" type="checkbox"/> Field Rep.		Date Revised June 18, 2013	
Applicable Model  CX-5 (KE)	Applicable Countries or Specifications  Worldwide

## Subject: Rattle noise from front door window glass

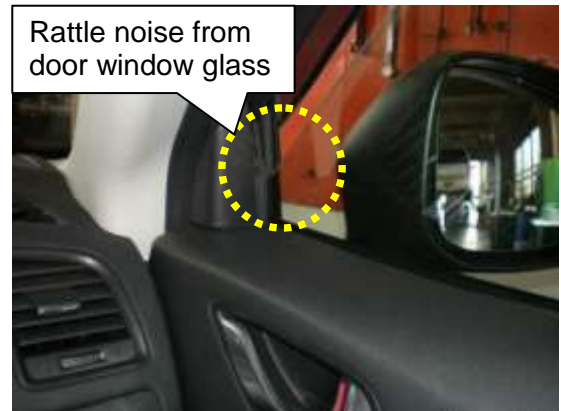
When driving a vehicle with the front door window glass partially opened for about 1 to 10 cm from the closed position, the door window glass causes a rattle noise.

The holding force of glass run channel is not sufficient.

The shape of glass run channel has been changed to increase the holding force.
