Service Information

Category T	Repair Guidance	Ref. No. R056/13	Page 1 of 3
Coverage Distributor only Please inform your dealers		Date Issued July 16, 2013	
Please convey this information to your Director General Manager Warranty Dept. Parts Dept. Training Dept. Field Rep.		Date Revised	
Applicable Model CX-5 (KE) and Mazda6 (GJ) Sedan equipped with Theft-Deterrent System		Applicable Countries or Specifications Worldwide

Subject: Noise from right rear of vehicle when closing rear door/trunk lid or driving on rough road.

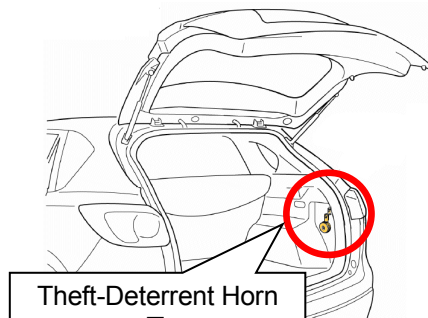
CX-5

The noise may be caused by the theft-deterrent horn bracket which resonates with the body panel when vibration is given to the vehicle.

Theft-Deterrent Horn

A EPT sealer has been attached to the theft deterrent horn to eliminate the noise.

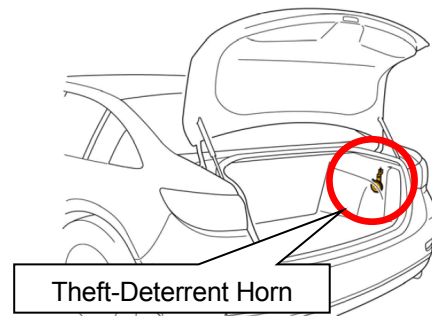
Mazda6 Sedan

Theft-Deterrent Horn
