# Service Information

Category <b>N</b>	<b>Repair Guidance</b>	Ref. No. R067/13	Page 1 of 2
Coverage <input type="checkbox"/> Distributor only <input checked="" type="checkbox"/> Please inform your dealers		Date Issued August 28, 2013	
Please convey this information to your <input type="checkbox"/> Director <input checked="" type="checkbox"/> General Manager <input checked="" type="checkbox"/> Warranty Dept. <input checked="" type="checkbox"/> Parts Dept. <input checked="" type="checkbox"/> Training Dept. <input checked="" type="checkbox"/> Field Rep.		Date Revised	
Applicable Model  Mazda6(GJ)		Applicable Countries or Specifications  Europe

## Subject: Unusual noise when vehicle is started with steering wheel fully turned to driver-side

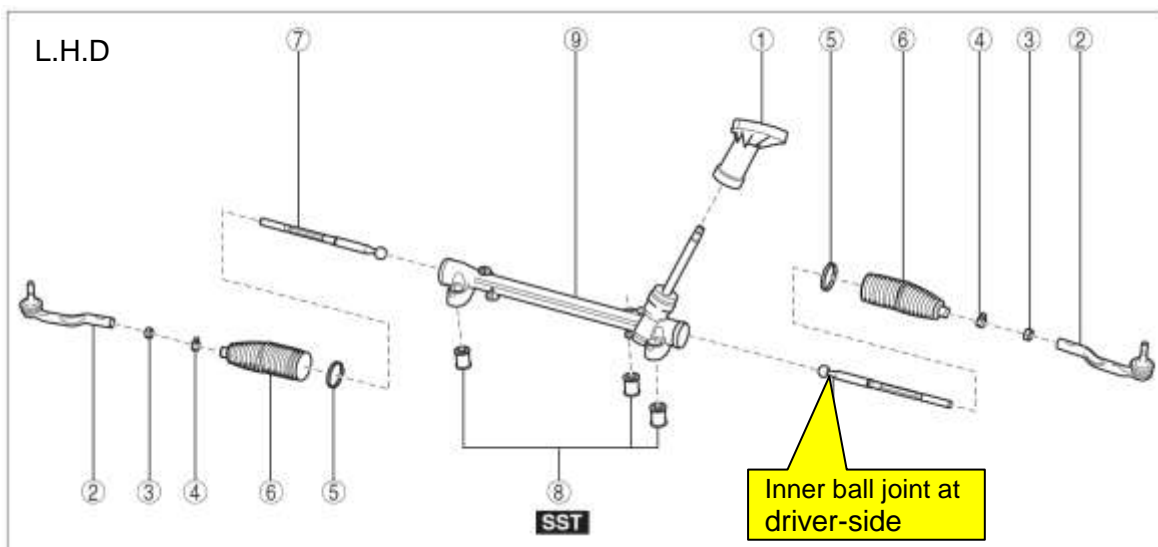
Some vehicles may exhibit an unusual noise (clacking) from under the vehicle front when the vehicle is started after the steering wheel is fully turned to the driver-side (left-side for LHD and right-side for RHD vehicle). The noise will not occur when the vehicle is started after the steering wheel is fully turned to the passenger-side.

An edge of the inner ball joint at the driver-side may get stuck with the steering gear housing, causing a stick-slip noise.

The shape of the inner ball joint edge has been changed.

**Note:** Refer to the noise sample in the attached video file.
2. If the noise is reproduced, remove the steering gear and linkage from the vehicle according to the Workshop Manual "STEERING GEAR AND LINKAGE REMOVAL" and replace the inner ball joint (driver-side) with a modified one according to the Workshop Manual "STEERING GEAR AND LINKAGE DISASSEMBLY".
3. Install the steering gear and linkage in the reverse order of removal.
4. Verify the repair.
