Service Information

+Category N	Repair Guidance	Ref. No. R070/13	Page 1 of 2
Coverage <input type="checkbox"/> Distributor only <input checked="" type="checkbox"/> Please inform your dealers		Date Issued September 17, 2013	
Please convey this information to your <input type="checkbox"/> Director <input checked="" type="checkbox"/> General Manager <input checked="" type="checkbox"/> Warranty Dept. <input checked="" type="checkbox"/> Parts Dept. <input checked="" type="checkbox"/> Training Dept. <input checked="" type="checkbox"/> Field Rep.		Date Revised	
Applicable Model CX-5 (KE)		Applicable Countries or Specifications Worldwide

Subject: Unusual noise when vehicle is started with steering wheel fully turned to driver-seat side

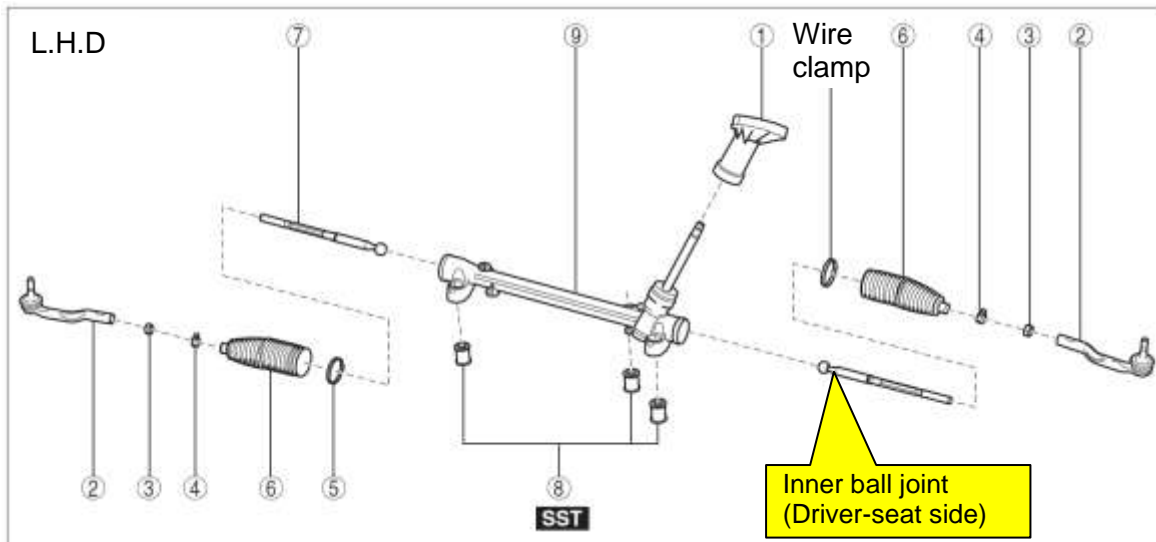
An edge of the inner ball joint at the driver-seat side may get stuck with the steering gear housing, causing a stick-slip noise.

The shape of the inner ball joint edge has been changed.

1. Verify customer complaint.
 - ① Stop the vehicle after the steering wheel is fully turned to the direction where the driver's seat is installed.
 - ② Verify that the noise occurs when starting the vehicle.
Note: Refer to the noise sample in the attached video file.
2. If the noise is reproduced, remove the steering gear and linkage from the vehicle according to the Workshop Manual "STEERING GEAR AND LINKAGE REMOVAL" and replace the inner ball joint (driver-seat side) with a modified one according to the Workshop Manual "STEERING GEAR AND LINKAGE DISASSEMBLY".
3. Install the steering gear and linkage in the reverse order of removal.
4. Verify the repair.
