Service Information

Category S	Repair Guidance	Ref. No. R069/13	Page 1 of 3
Coverage <input type="checkbox"/> Distributor only <input checked="" type="checkbox"/> Please inform your dealers		Date Issued September 6, 2013	
Please convey this information to your <input type="checkbox"/> Director <input checked="" type="checkbox"/> General Manager <input checked="" type="checkbox"/> Warranty Dept. <input checked="" type="checkbox"/> Parts Dept. <input checked="" type="checkbox"/> Training Dept. <input checked="" type="checkbox"/> Field Rep.		Date Revised	
Applicable Model CX-5 (KE) with leather seat	Applicable Countries or Specifications Worldwide

Subject: Front seat back trim coming apart at seams

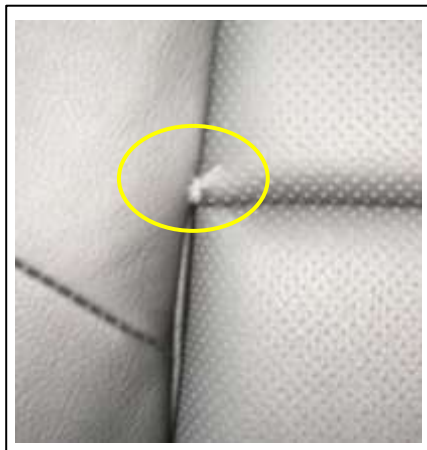
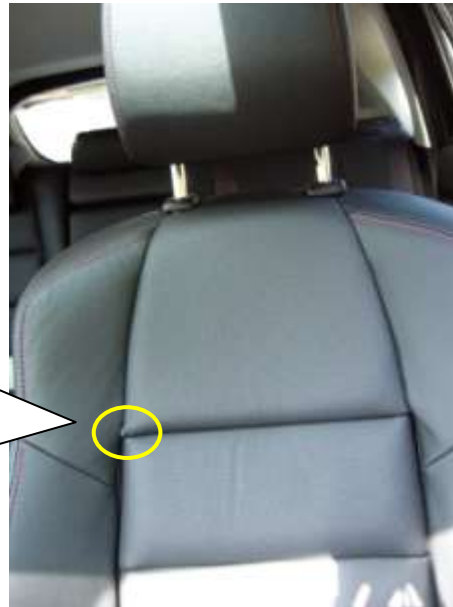
Some vehicles may exhibit a condition where the front seat back trim is coming apart at the seams as shown in pictures.

Sewing at the concerned area is not strong enough.

The sewing method has been changed to increase strength.

Replace the front seat back trim with a new modified service part.
