Service Information

Category S	Repair Guidance	Ref. No. R077/12A	Page 1 of 3
Coverage <input type="checkbox"/> Distributor only <input checked="" type="checkbox"/> Please inform your dealers		Date Issued October 30, 2012	
Please convey this information to your <input type="checkbox"/> Director <input checked="" type="checkbox"/> General Manager <input checked="" type="checkbox"/> Warranty Dept. <input checked="" type="checkbox"/> Parts Dept. <input checked="" type="checkbox"/> Training Dept. <input checked="" type="checkbox"/> Field Rep.		Date Revised September 30, 2013	
Applicable Model CX-5 (KE) with 4:2:4 split-type rear seat	Applicable Countries or Specifications Worldwide

Subject: Unable to Fold Rear Seatback by Remote Handle Lever, or Difficult to lock them

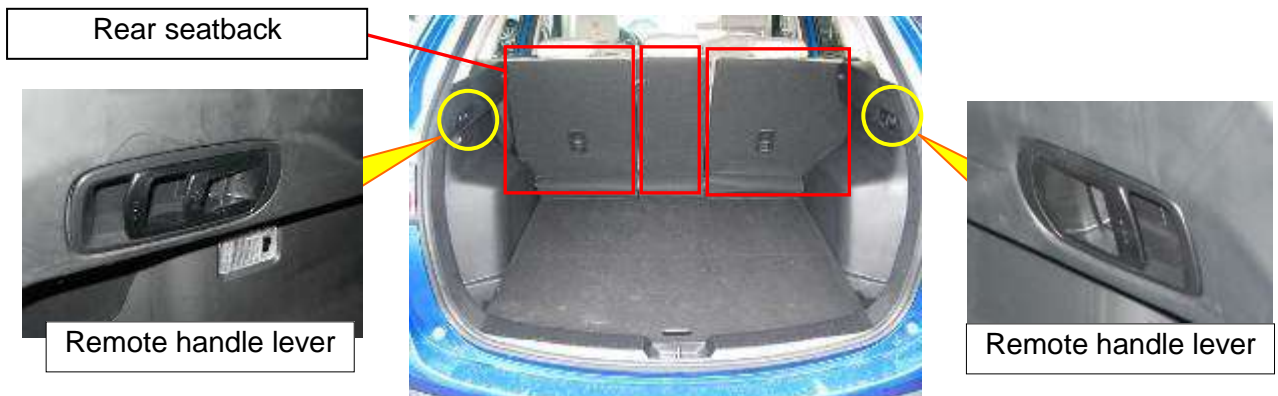
On some vehicles, the rear seatbacks (right, left and/or center) cannot be folded by the remote handle lever, or difficult to lock them.

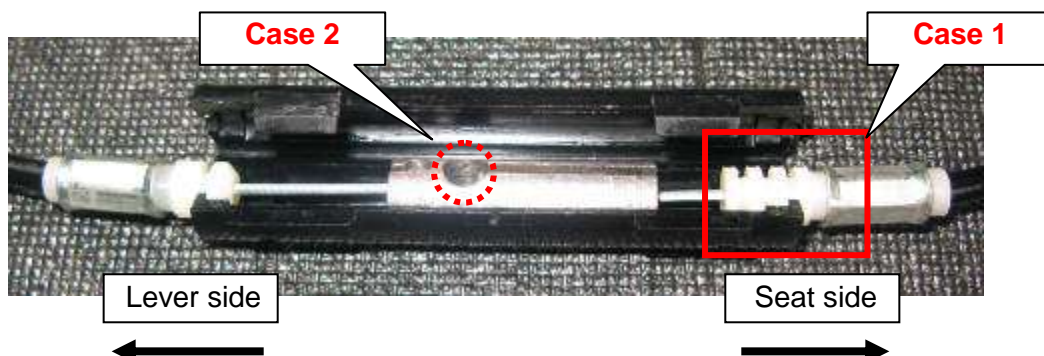
The cable ball gets seized on sharp edges inside the cylinder.

The sharp edges have been finished to round shape.
