Service Information

Category S	Repair Guidance	Ref. No. R073/13	Page 1 of 4
Coverage <input type="checkbox"/> Distributor only <input checked="" type="checkbox"/> Please inform your dealers		Date Issued September 30, 2013	
Please convey this information to your <input type="checkbox"/> Director <input checked="" type="checkbox"/> General Manager <input checked="" type="checkbox"/> Warranty Dept. <input checked="" type="checkbox"/> Parts Dept. <input checked="" type="checkbox"/> Training Dept. <input checked="" type="checkbox"/> Field Rep.		Date Revised	
Applicable Model CX-5 (KE) without power seat system		Applicable Countries or Specifications Worldwide

Subject: Noise from under the driver seat

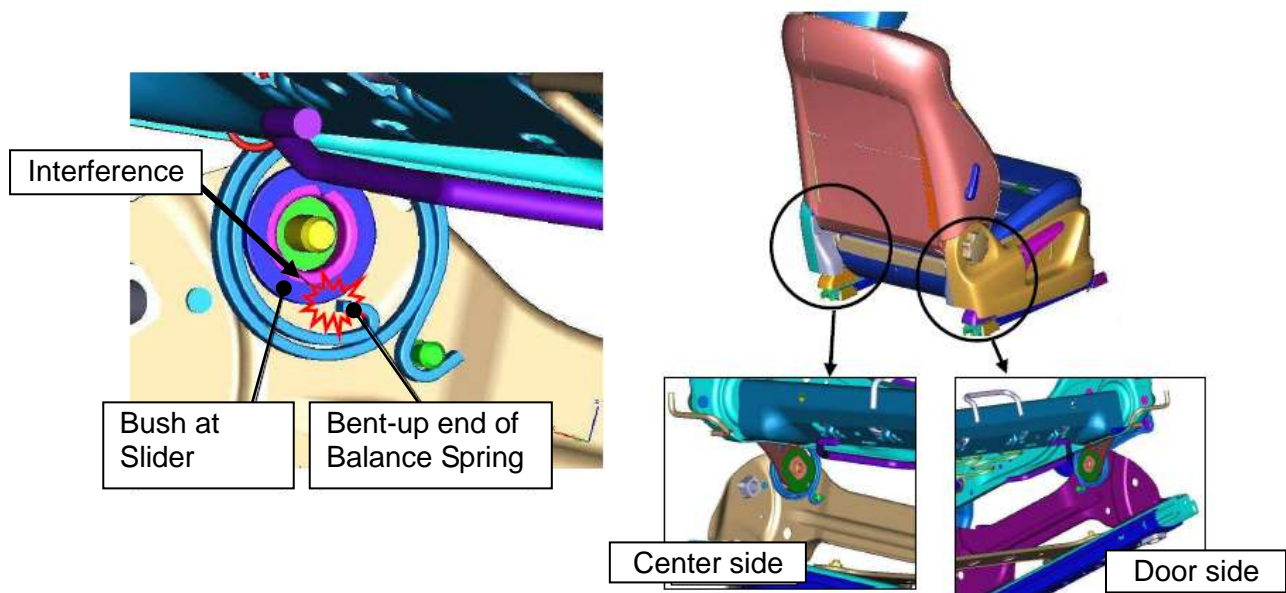
Some vehicles may exhibit a rasping noise from under the driver seat caused by vibration during driving.

The bent-up end of balance spring interferes with the bush at slider causing a rasping noise.

Clearance between the balance spring bent-up end and the bush at slider has been increased.
