Service Information

REVISED

Subject: DTC P2610:00 stored

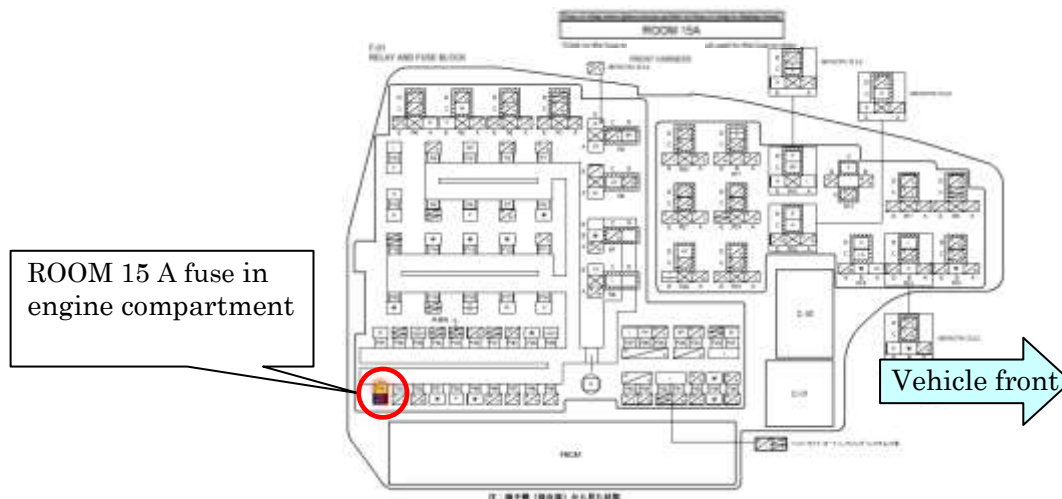
On some vehicles, P2610:00 may be stored in memory as MIL illumination or past malfunction after engine start with room fuse removed. As past malfunction case does not affect anything (no warning light illumination), the customer does not notice it, but the DTC may be found at any chance of service opportunity.

P2610:00: Instrument cluster internal engine off timer performance problem

If engine is started with the below condition, the DTC P2610 may be stored and the MIL illuminates.

- * The engine is started 3 times or more after a shorter duration of engine off less than 15 seconds with room fuse removed.

When the MIL is illuminated (DTC P2610) without room fuse at PDI, delete the DTC code following the procedure below.

- 1) Install the room fuse with IG switch off position.
- 2) Start the engine and run it 10 seconds or more, and then stop the engine.
- 3) Start the engine again and confirm the MIL is not illuminated, and then stop the engine.
- 4) Clear the DTC P2610.
- 5) If the DTC P2610 is still stored, perform troubleshooting according to Workshop Manual.
