Service Information

Category S	Repair Guidance	Ref. No. R029/12B	Page 1 of 4
Coverage <input type="checkbox"/> Distributor only <input checked="" type="checkbox"/> Please inform your dealers		Date Issued April 6, 2012	
Please convey this information to your <input type="checkbox"/> Director <input checked="" type="checkbox"/> General Manager <input checked="" type="checkbox"/> Warranty Dept. <input checked="" type="checkbox"/> Parts Dept. <input checked="" type="checkbox"/> Training Dept. <input checked="" type="checkbox"/> Field Rep.		Date Revised October 31, 2013	
Applicable Model CX-5 (KE)		Applicable Countries or Specifications Worldwide

Subject: Chirp noise from rear right over 100 km/h (62 MPH)

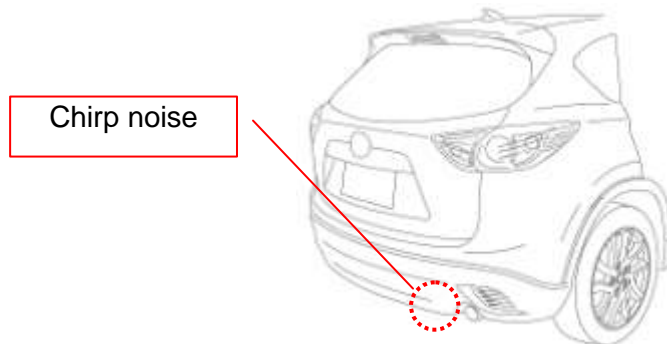
When driving at 100 km/h (62 MPH) or more, some vehicles may exhibit chirp noise from rear right side.

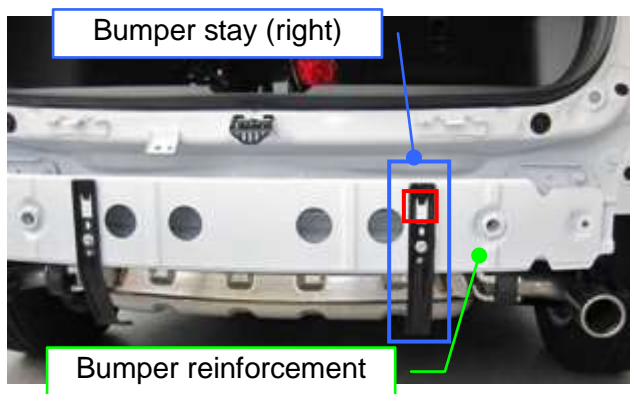
<Bumper removed off condition>

Hook of the right side rear bumper stay and bumper reinforcement is touching in one point. In this case, this may result in a chirp noise by body vibration and wind force at high speed.

Pads have been applied to the bumper stay to avoid contact noise.
