# Service Information

Category <b>S</b>	<b>Repair Guidance</b>	Ref. No. R029/14	Page 1 of 4
Coverage <input type="checkbox"/> Distributor only <input checked="" type="checkbox"/> Please inform your dealers		Date Issued March 5, 2014	
Please convey this information to your <input type="checkbox"/> Director <input checked="" type="checkbox"/> General Manager <input checked="" type="checkbox"/> Warranty Dept. <input checked="" type="checkbox"/> Parts Dept. <input checked="" type="checkbox"/> Training Dept. <input checked="" type="checkbox"/> Field Rep.		Date Revised	
Applicable Model  Mazda3 (BM)	Applicable Countries or Specifications  Worldwide

## Subject: Buzzing noise from around driver-side dashboard

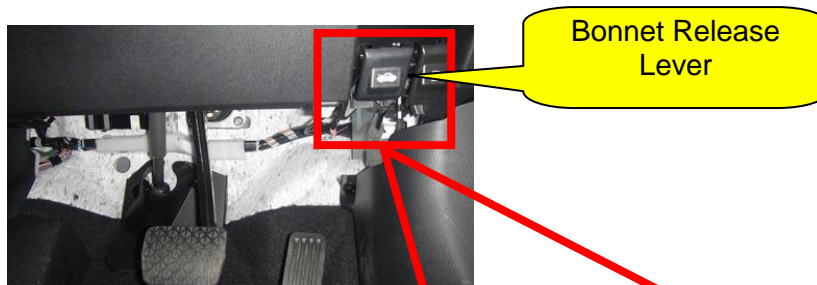
<RHD vehicle>

The buzzing noise may be caused by the bonnet release inner wire contacting the outer cable by impact from a rough road. The noise is heard from around the driver side dashboard.

1. Verify customer complaint.
2. Change the installation layout (bending angle) of the bonnet release cable in order to avoid the inner wire shaking in the outer cable even when receiving impact, and secure it to the harness using a band as shown in the picture on the next page.
