Service Information

Category S	Repair Guidance	Ref. No. R001/14A	Page 1 of 3
Coverage <input type="checkbox"/> Distributor only <input checked="" type="checkbox"/> Please inform your dealers		Date Issued January 6, 2014	
Please convey this information to your <input type="checkbox"/> Director <input checked="" type="checkbox"/> General Manager <input checked="" type="checkbox"/> Warranty Dept. <input checked="" type="checkbox"/> Parts Dept. <input checked="" type="checkbox"/> Training Dept. <input checked="" type="checkbox"/> Field Rep.		Date Revised March 27, 2014	
Applicable Model Mazda3(BM)		Applicable Countries or Specifications Worldwide

Subject: Rattle noise from the bottom of A-pillar

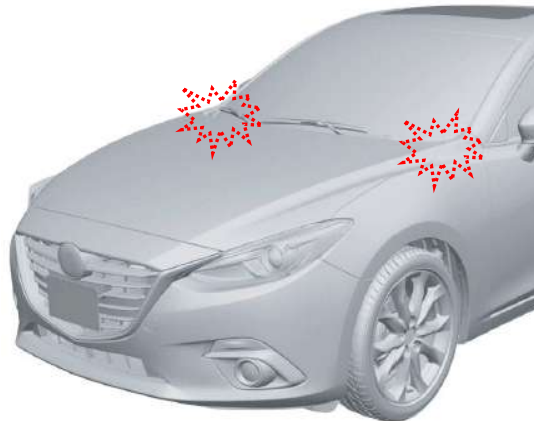
When driving on rough roads or over bumps, some vehicles may exhibit a rattle noise from the bottom of the A-pillar.

The cowl upper plate and/or dash upper panel interferes with the wiper bracket causing a noise.

When you encounter a customer complaint on this concern, create a clearance between the affected panels. (Between wiper bracket~Cowl upper plate and between wiper bracket~dash upper panel) by using the following procedure.
